Grant Assessment Document Report

Projects requiring maintenance

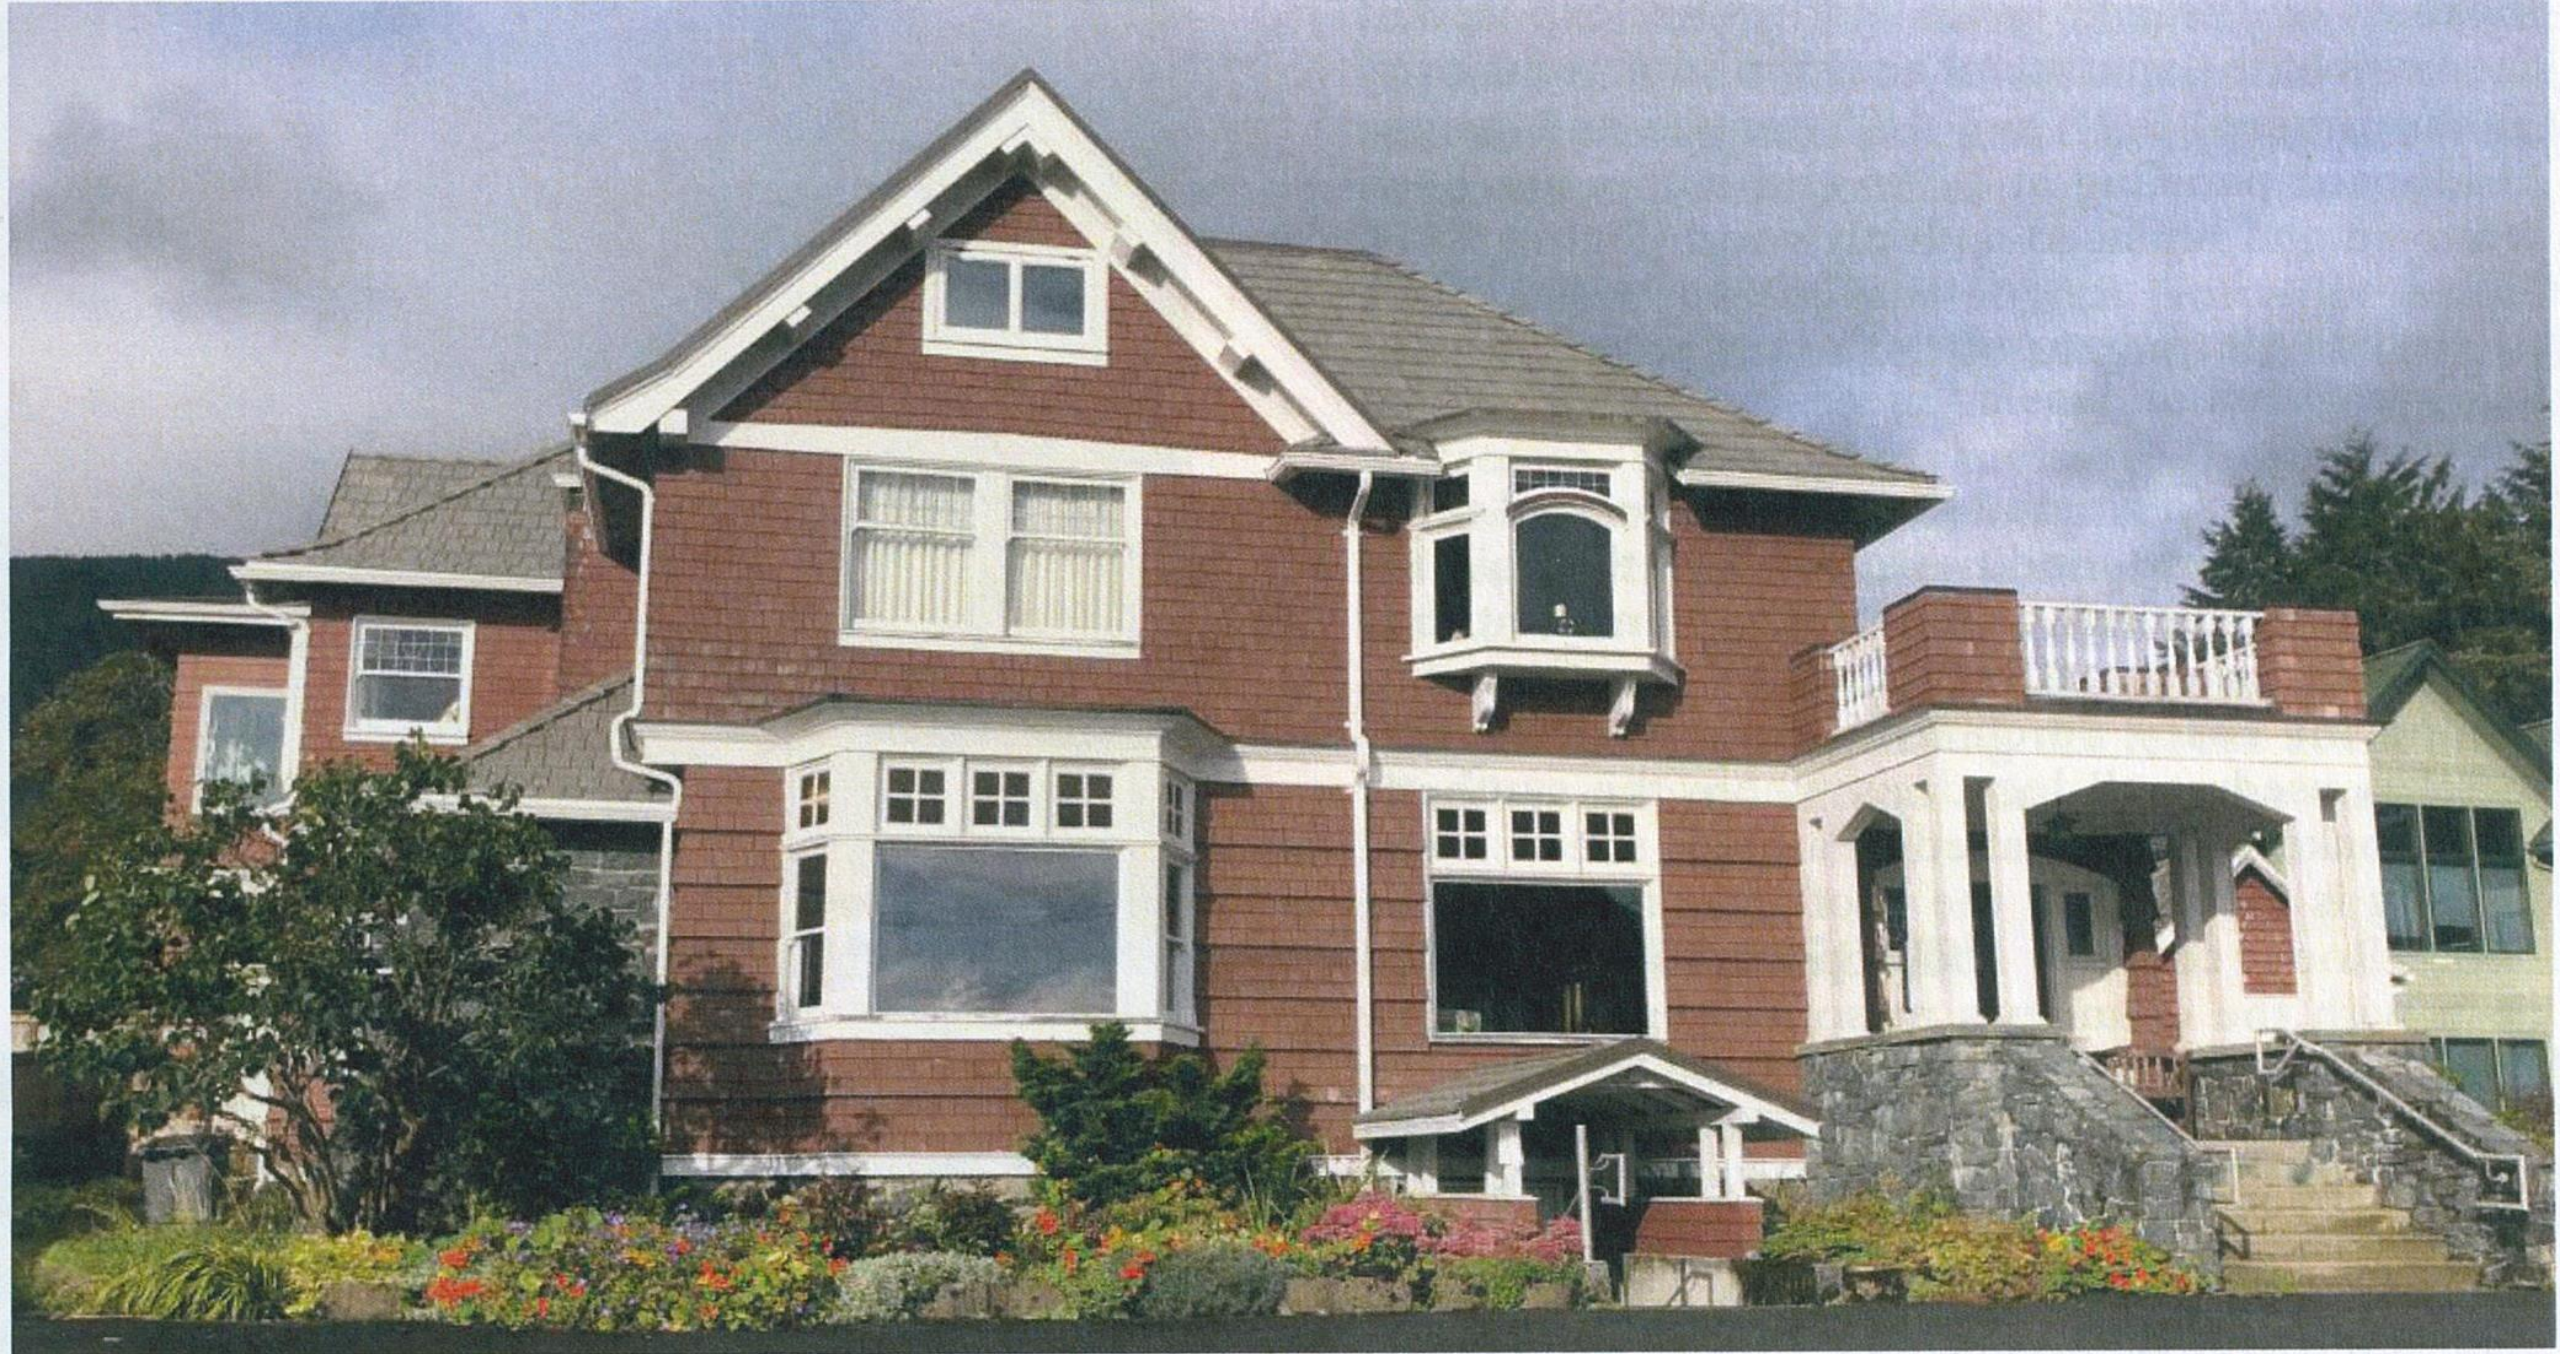
Figure 8.9: Synthetic (plastic) shakes have replaced the original cedar shingle roof.

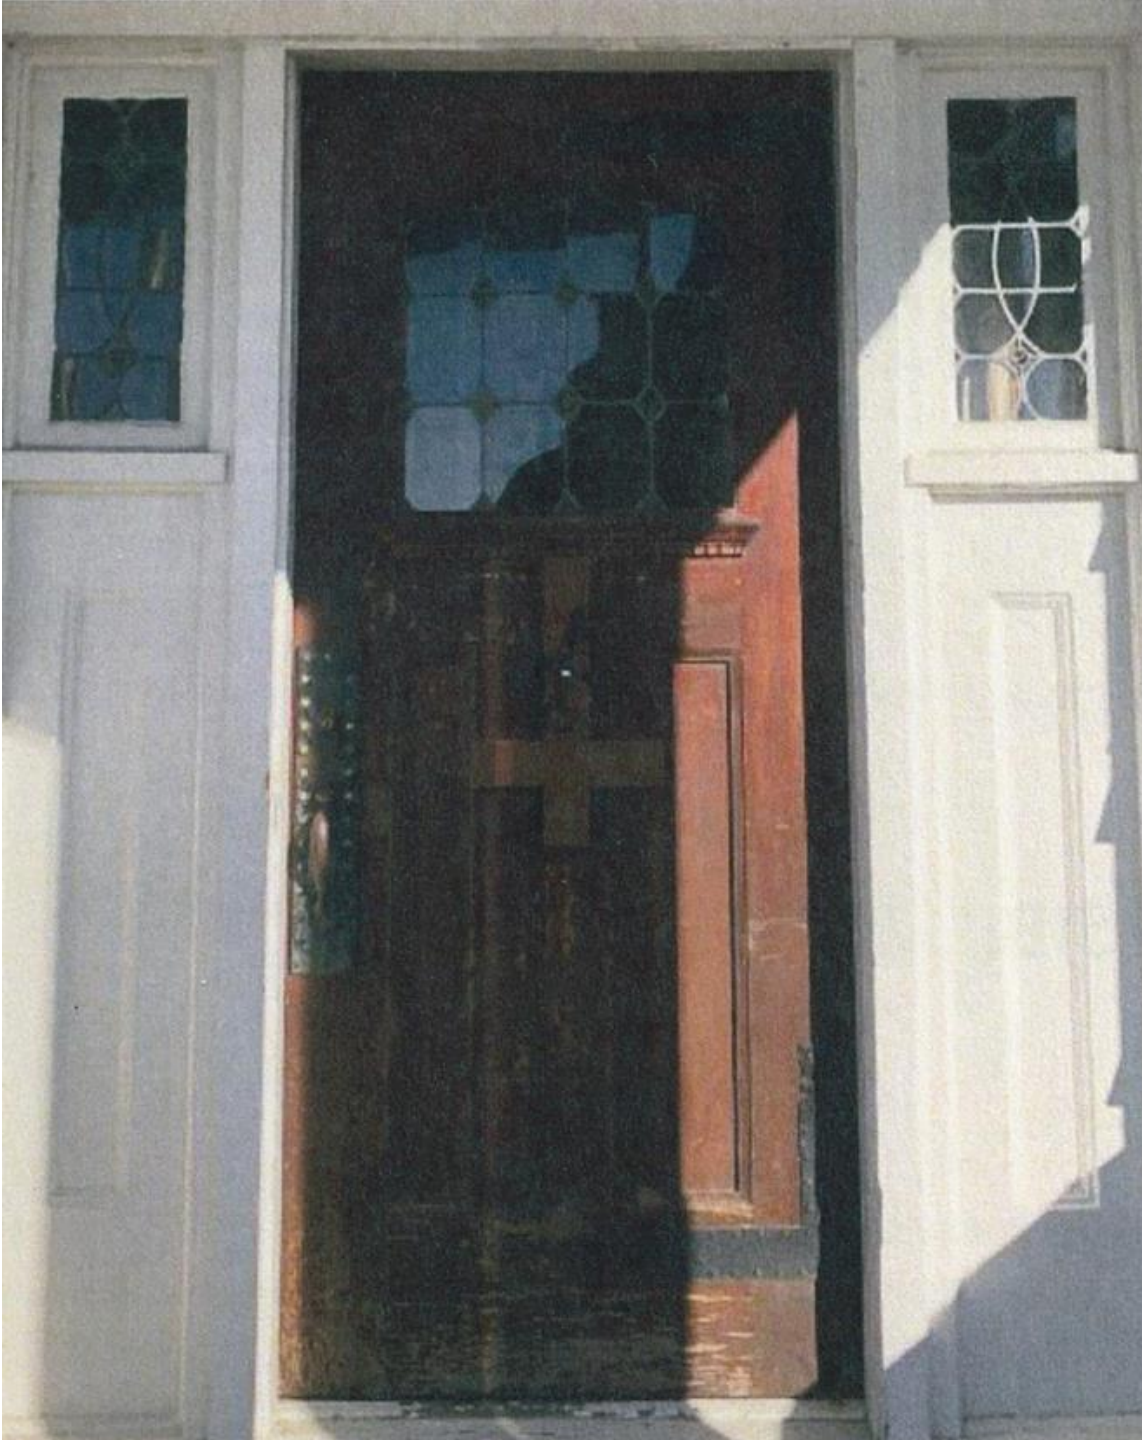
Thanks to Steve Gage we have a newly refinished front entrance door to See House.

Now need someone to replace lead cane and solder joints in stained glass window

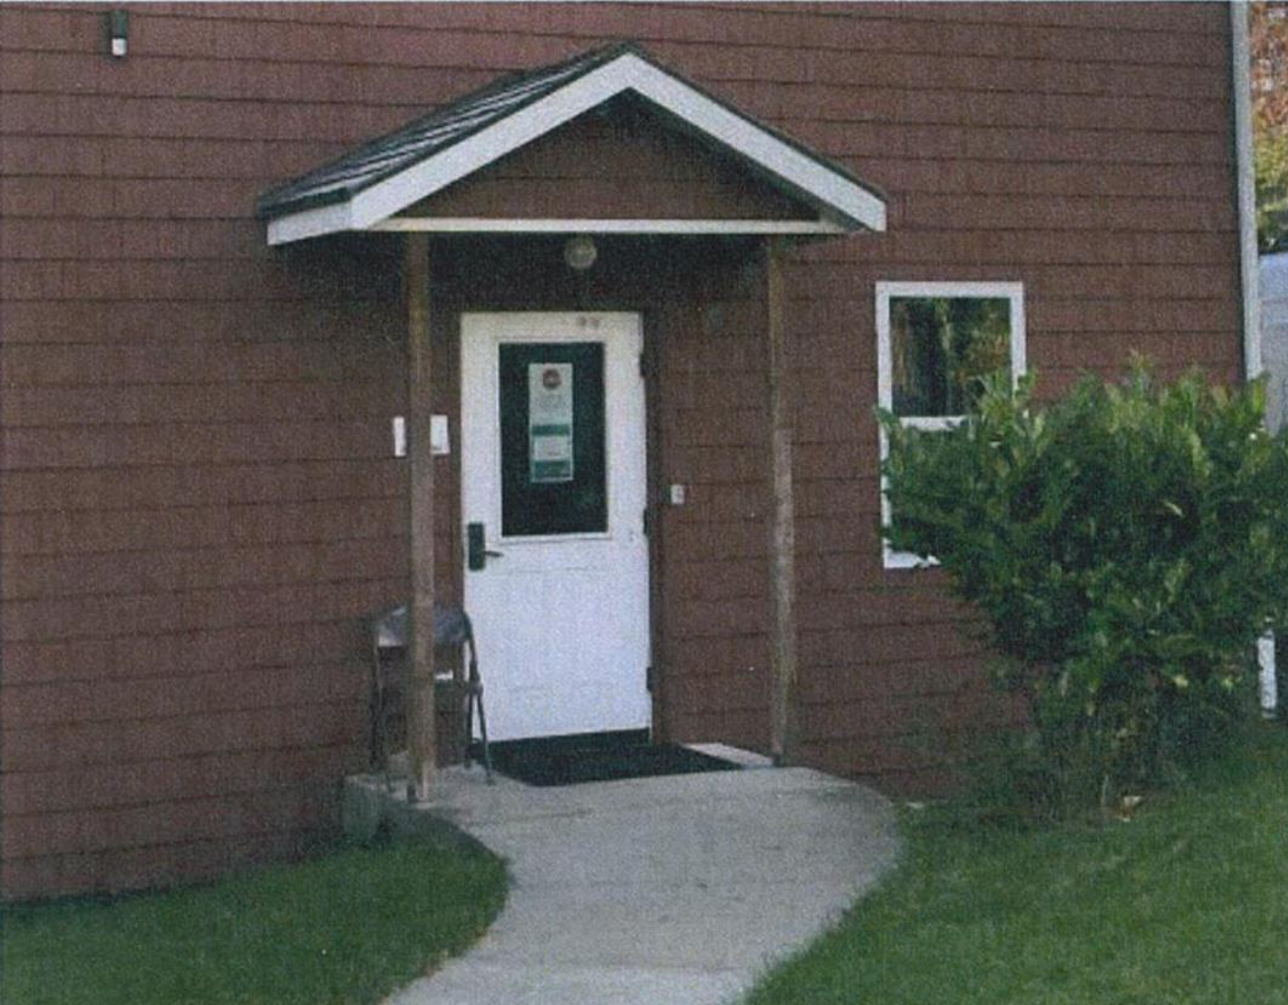
Landing outside of the Fellowship Hall entrance door does not have a code compliant clear floor area

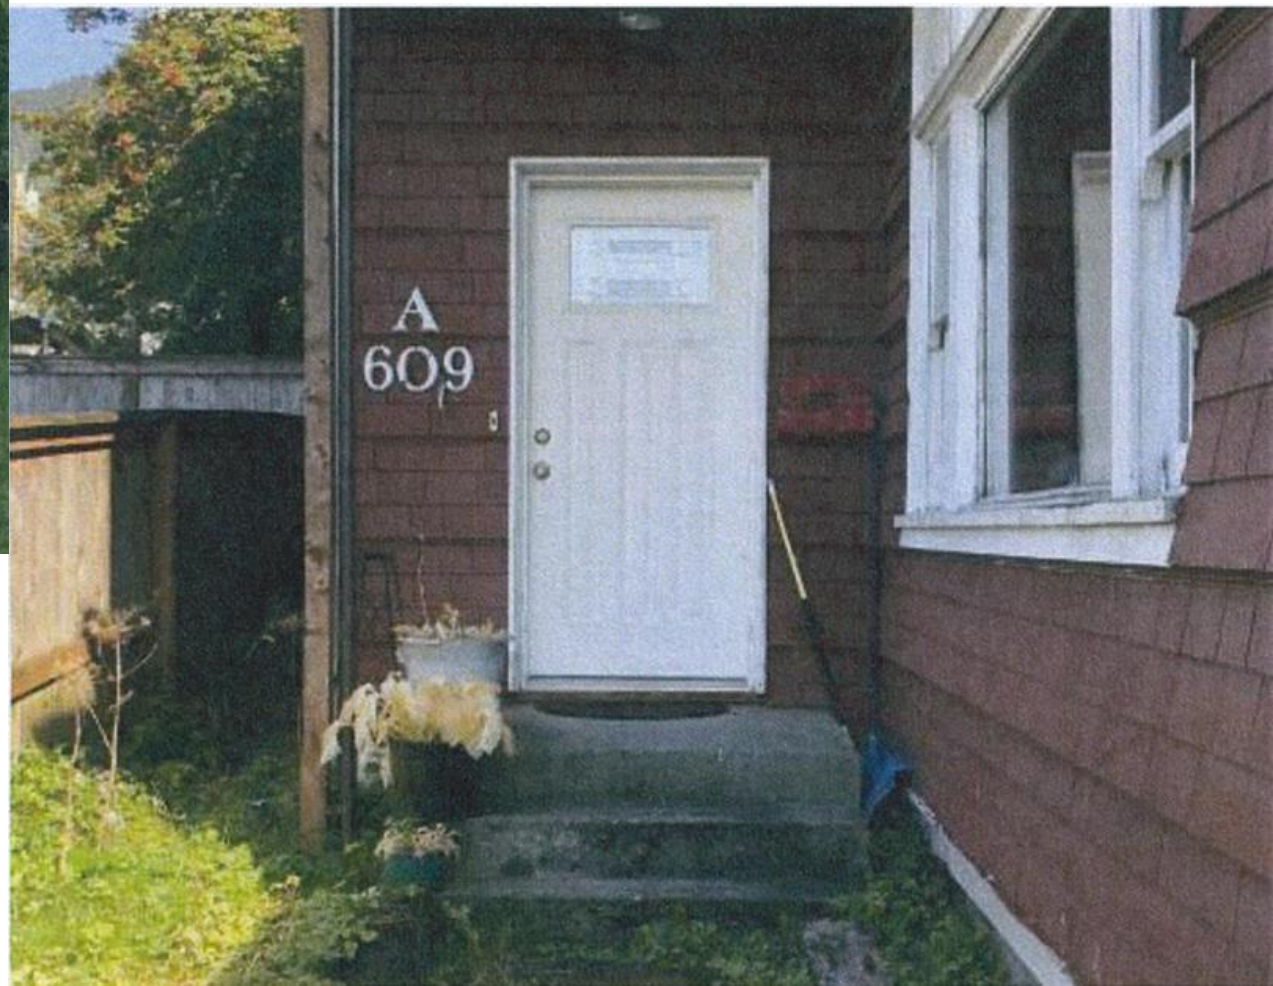
All entrances (except the main front door of See House) are not code compliant due to the absence of handrails and/or handrails on both sides.

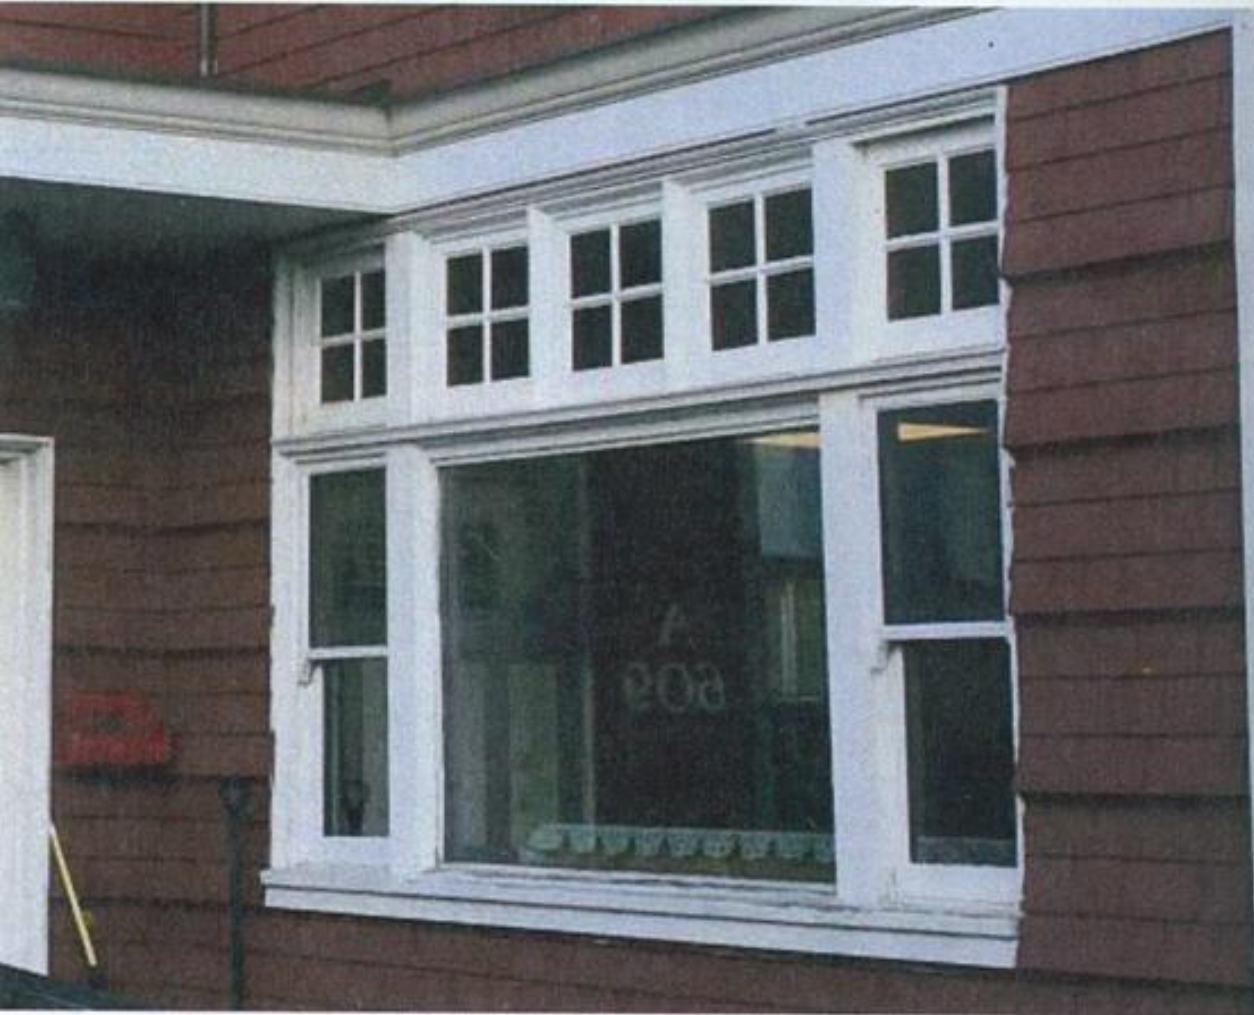
Sagging window header on dining room window.

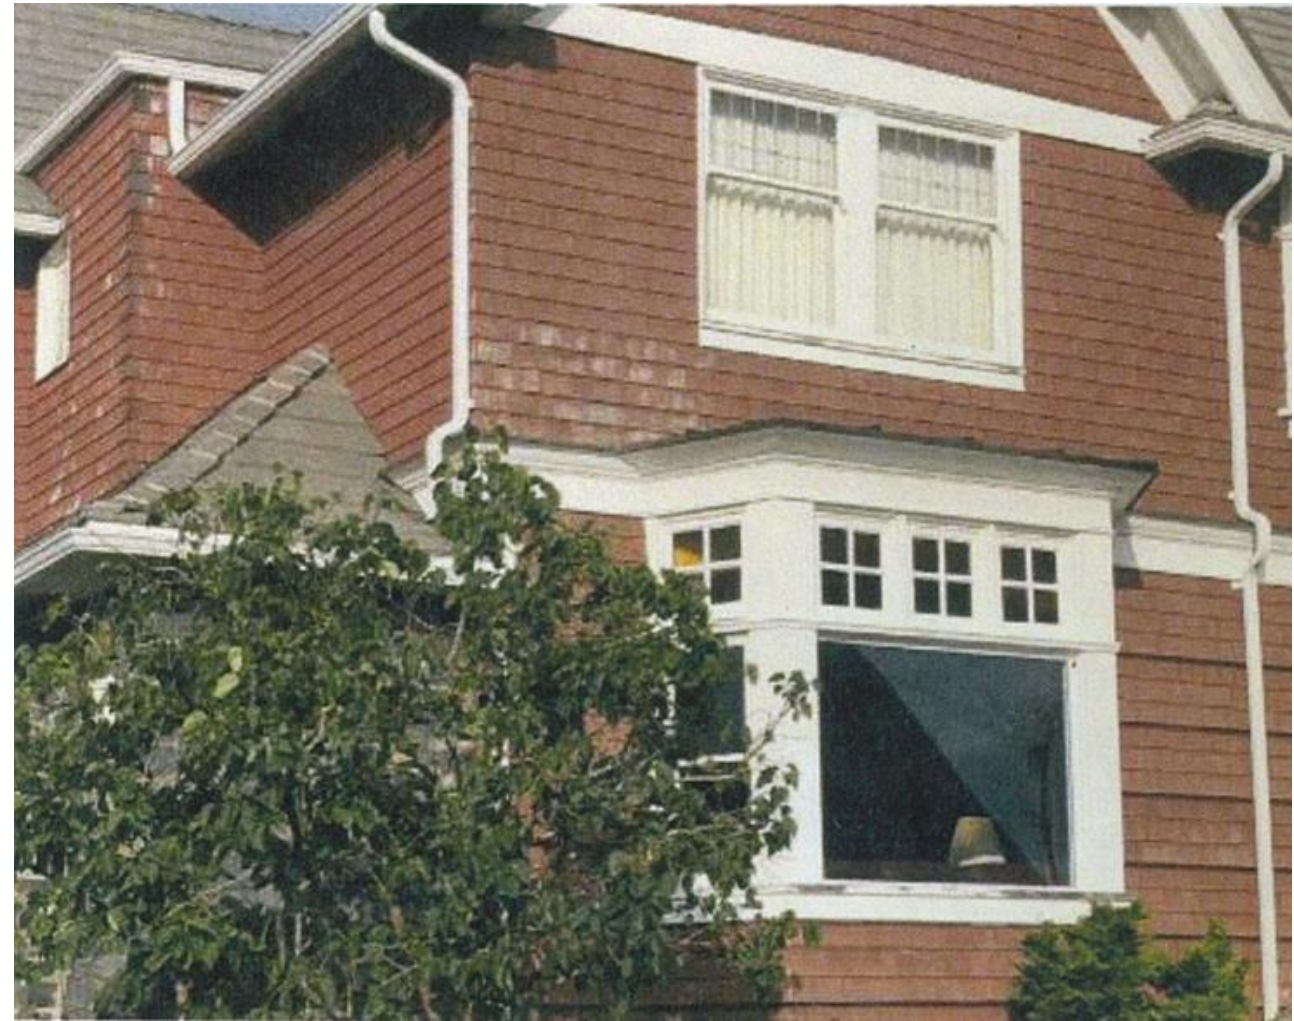
Window in front room has broken seal and when the wind blows from the “south” water is pushed up under flashing.

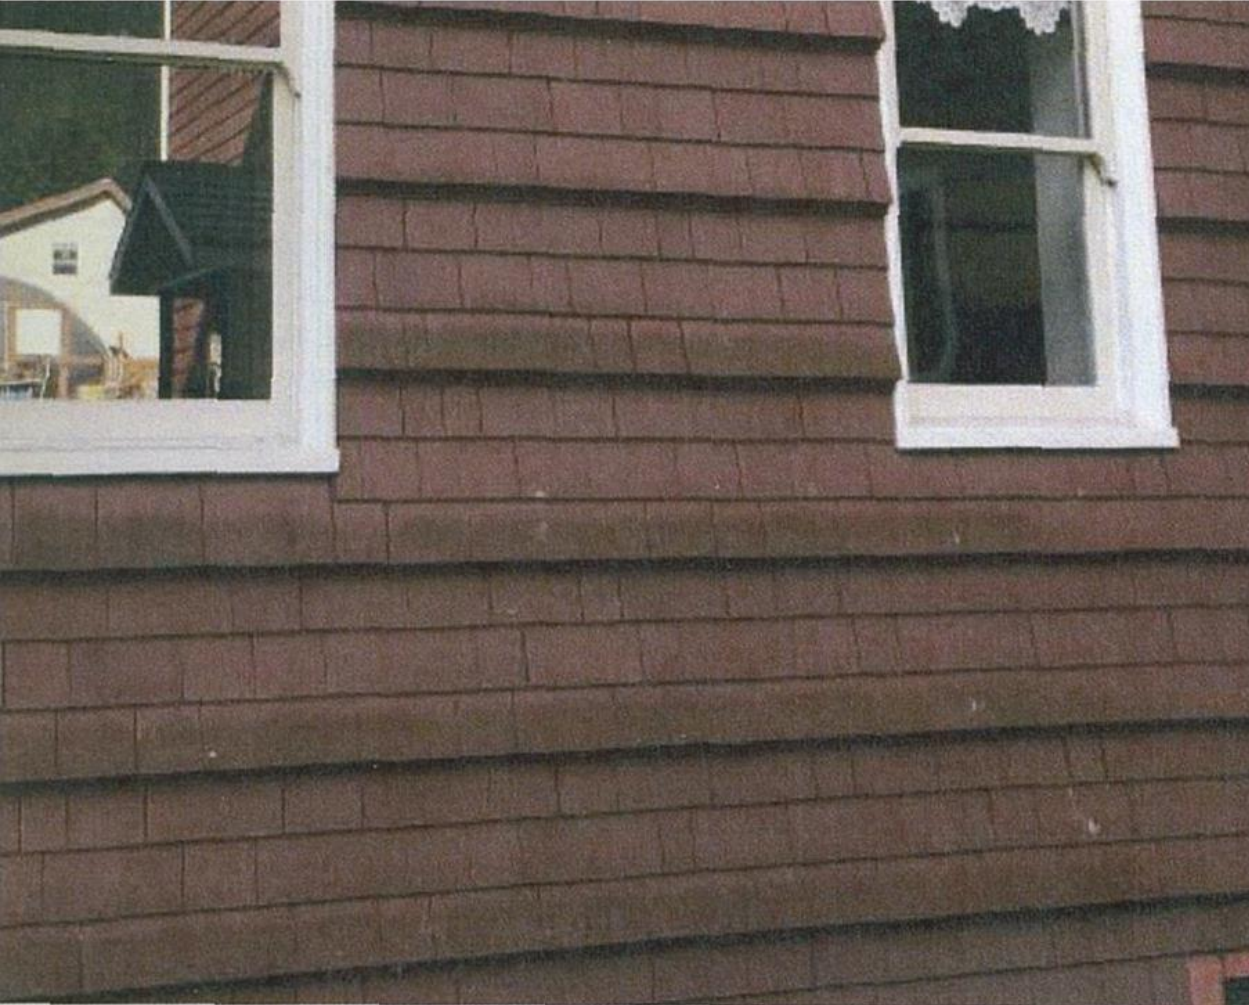
Mildew/soiling has accumulated on shingle siding, especially on the flared rows.

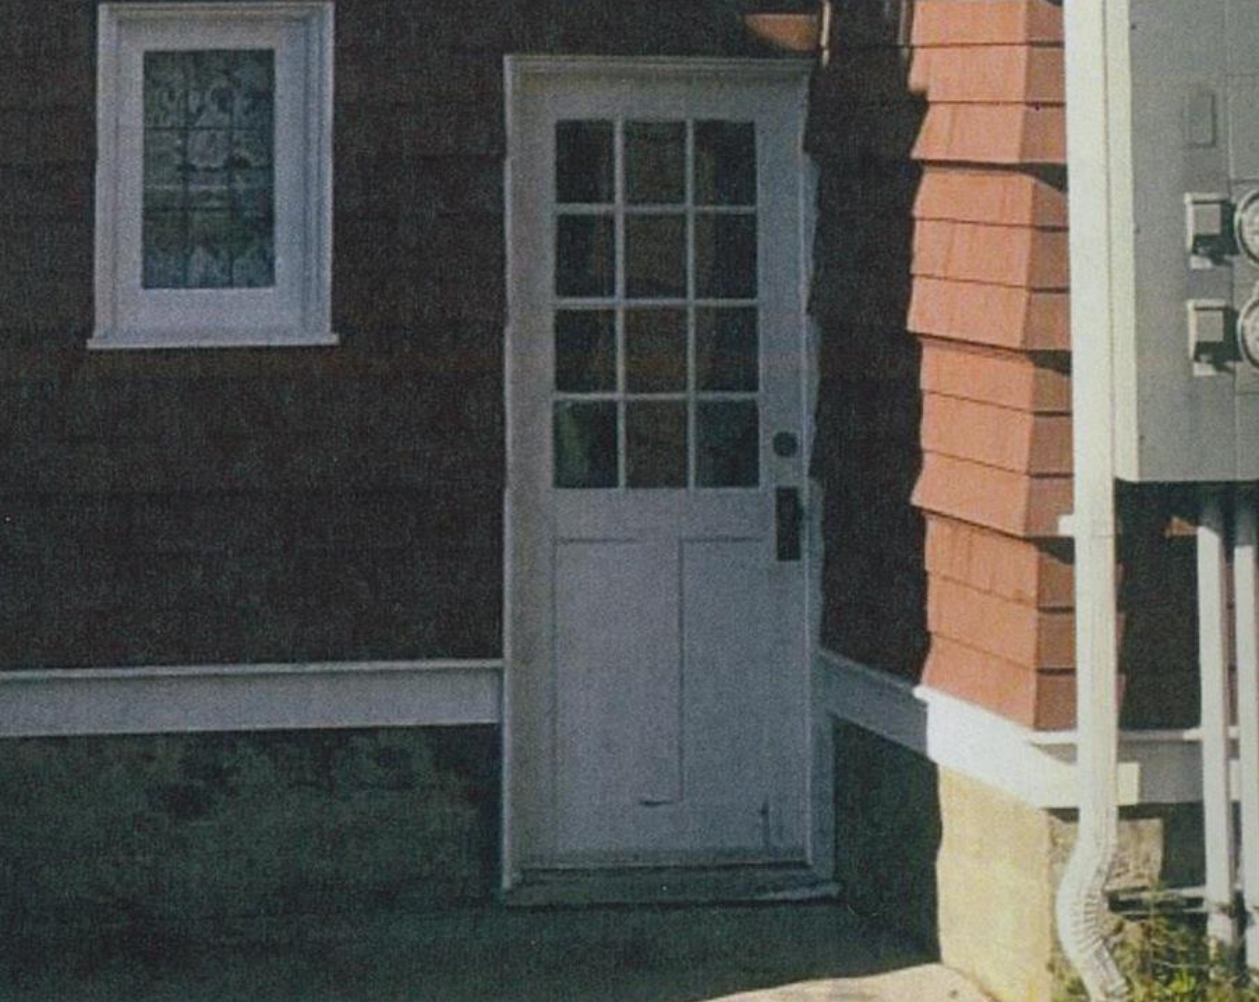
One of the original doors, but needs handrails to be code compliant OR possibly remove steps and have door be a non-functioning “decorative” door

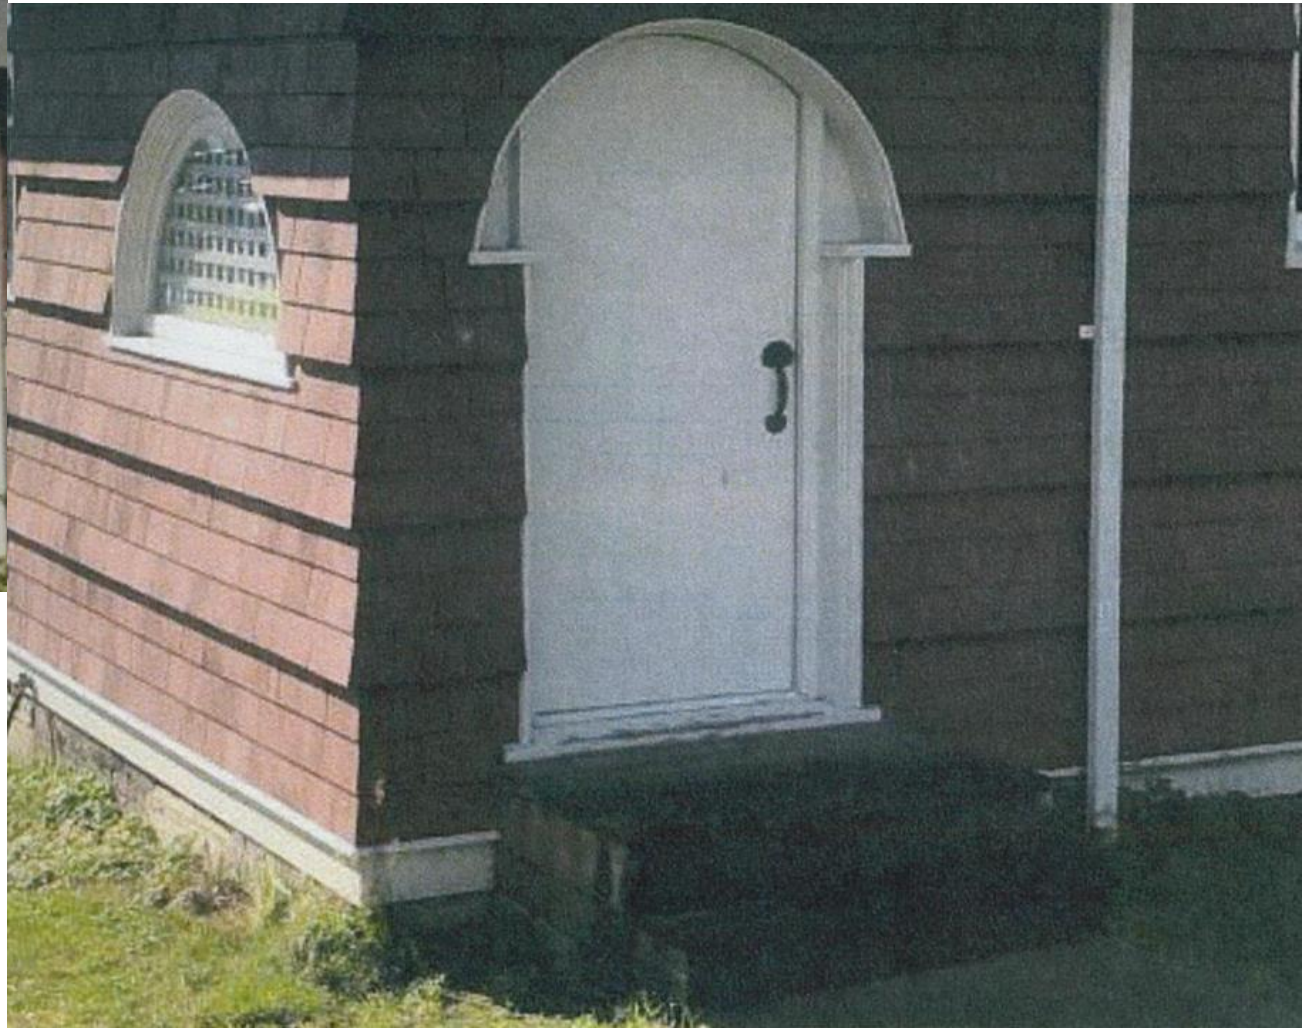
Kitchen/basement door needs lots of work and seals.

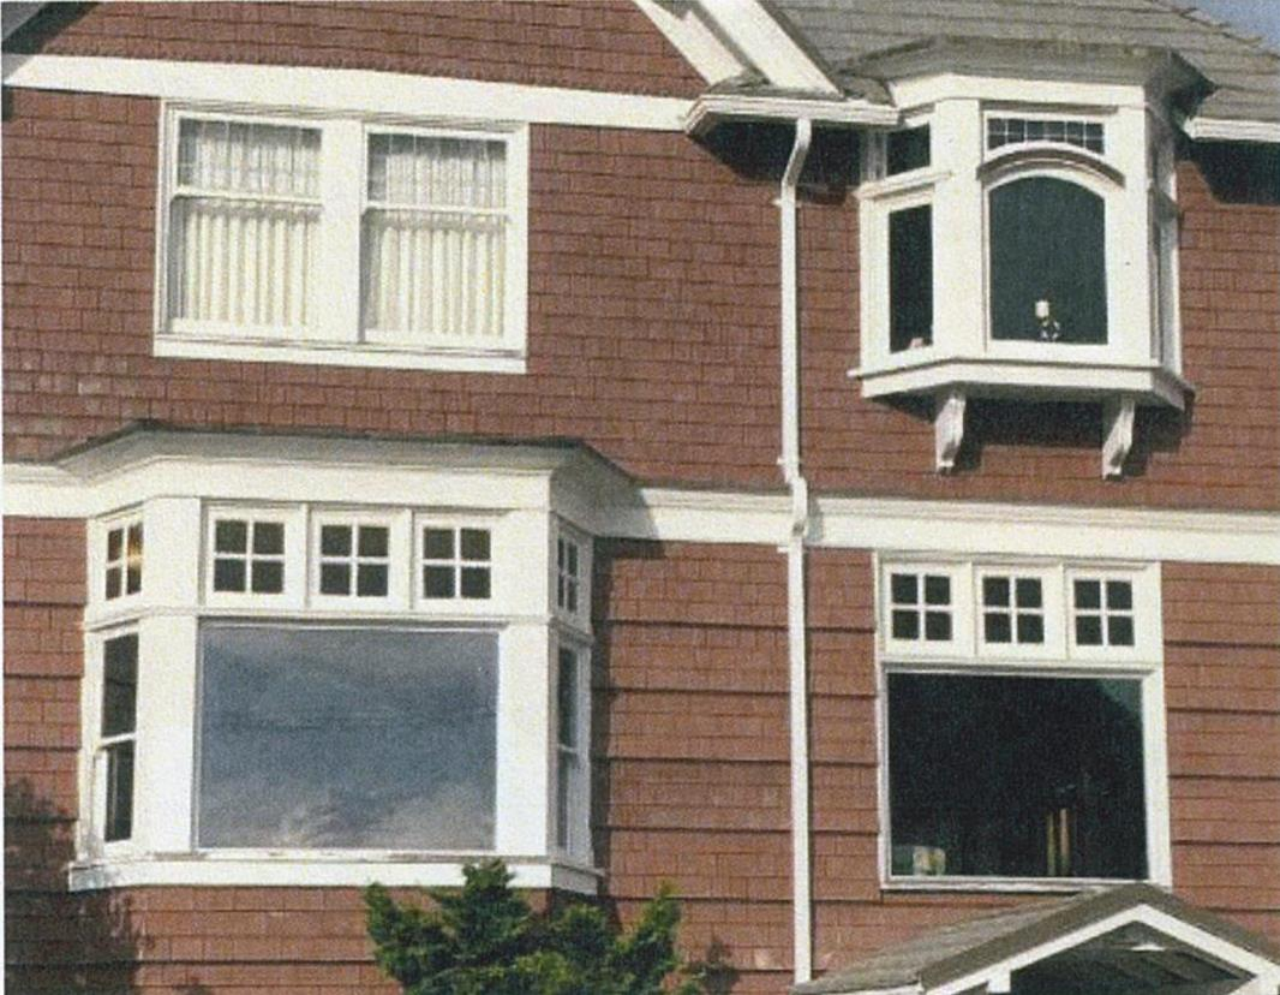
Weathered shingle siding, window frames need scraping, sanding and painting

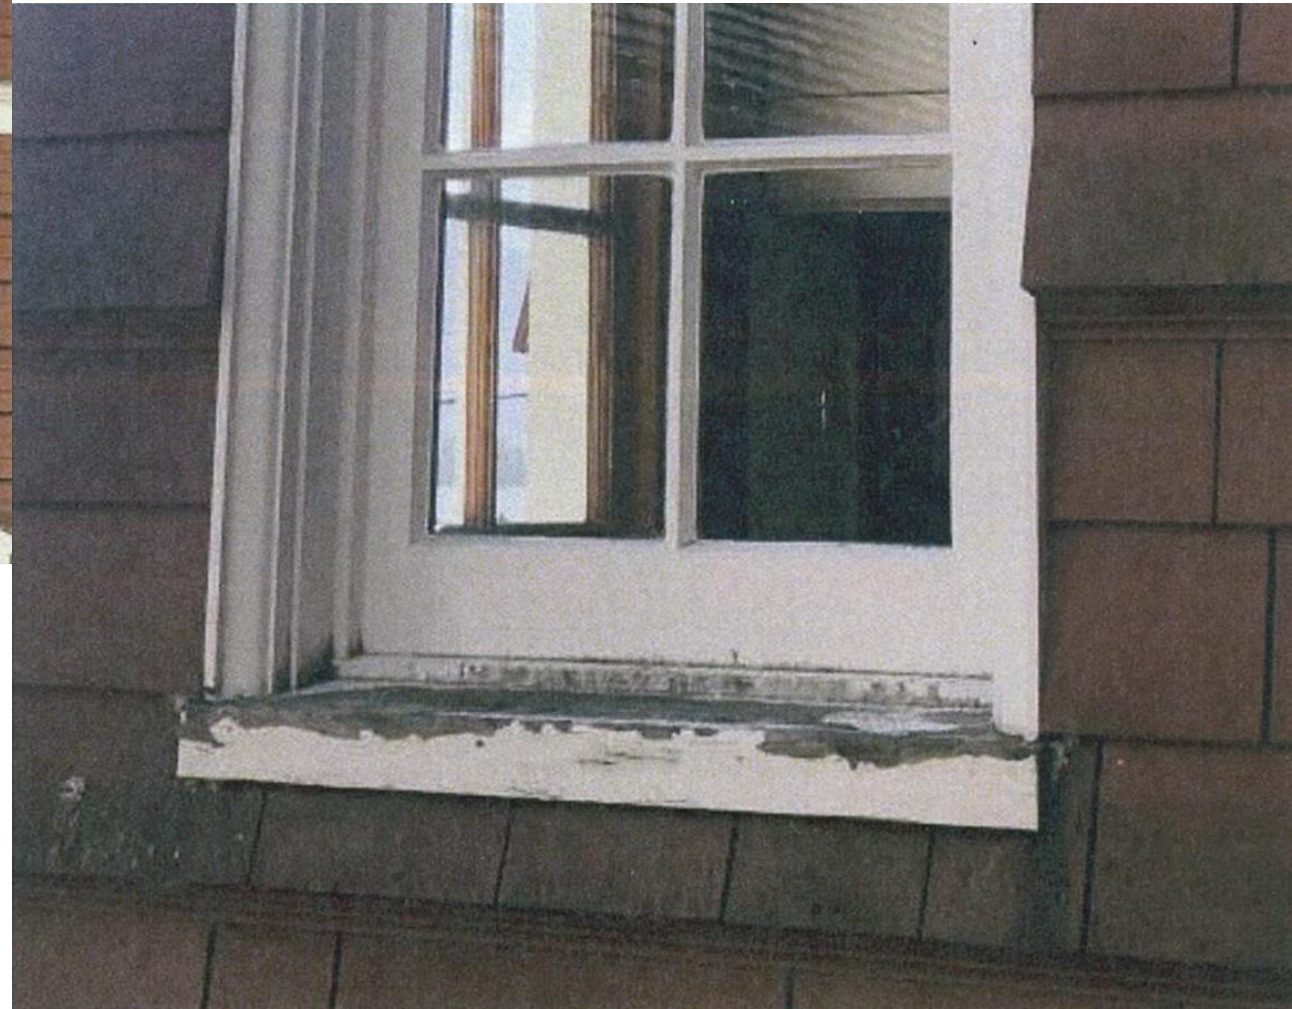
Window frame in Bishop's closet is in bad shape and rotted in some areas. Also need painting.

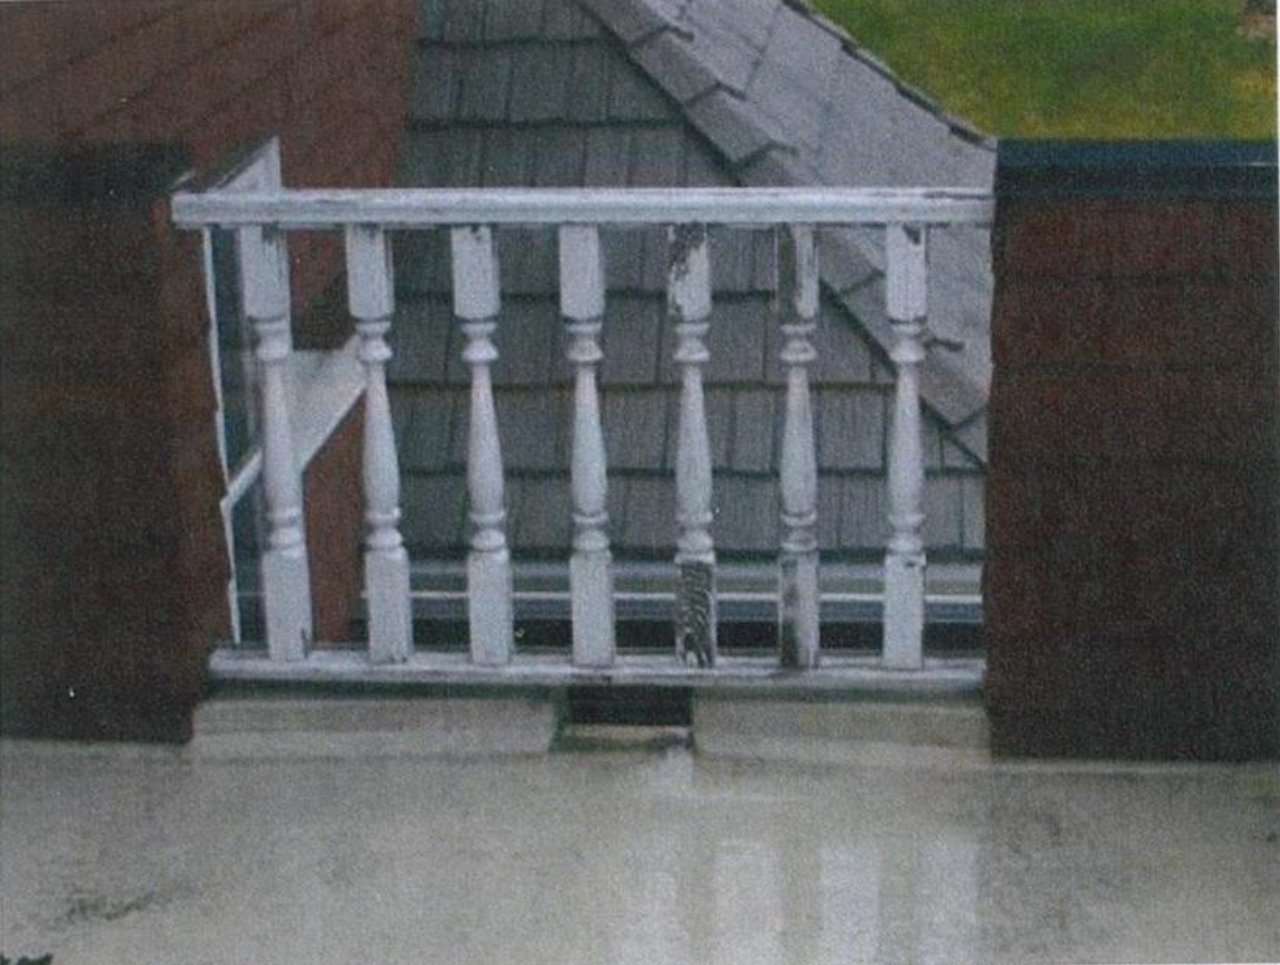
Balustrade on deck off Priest's office deck needs restoration and sealant under the door to stop water infiltration when the wind blows

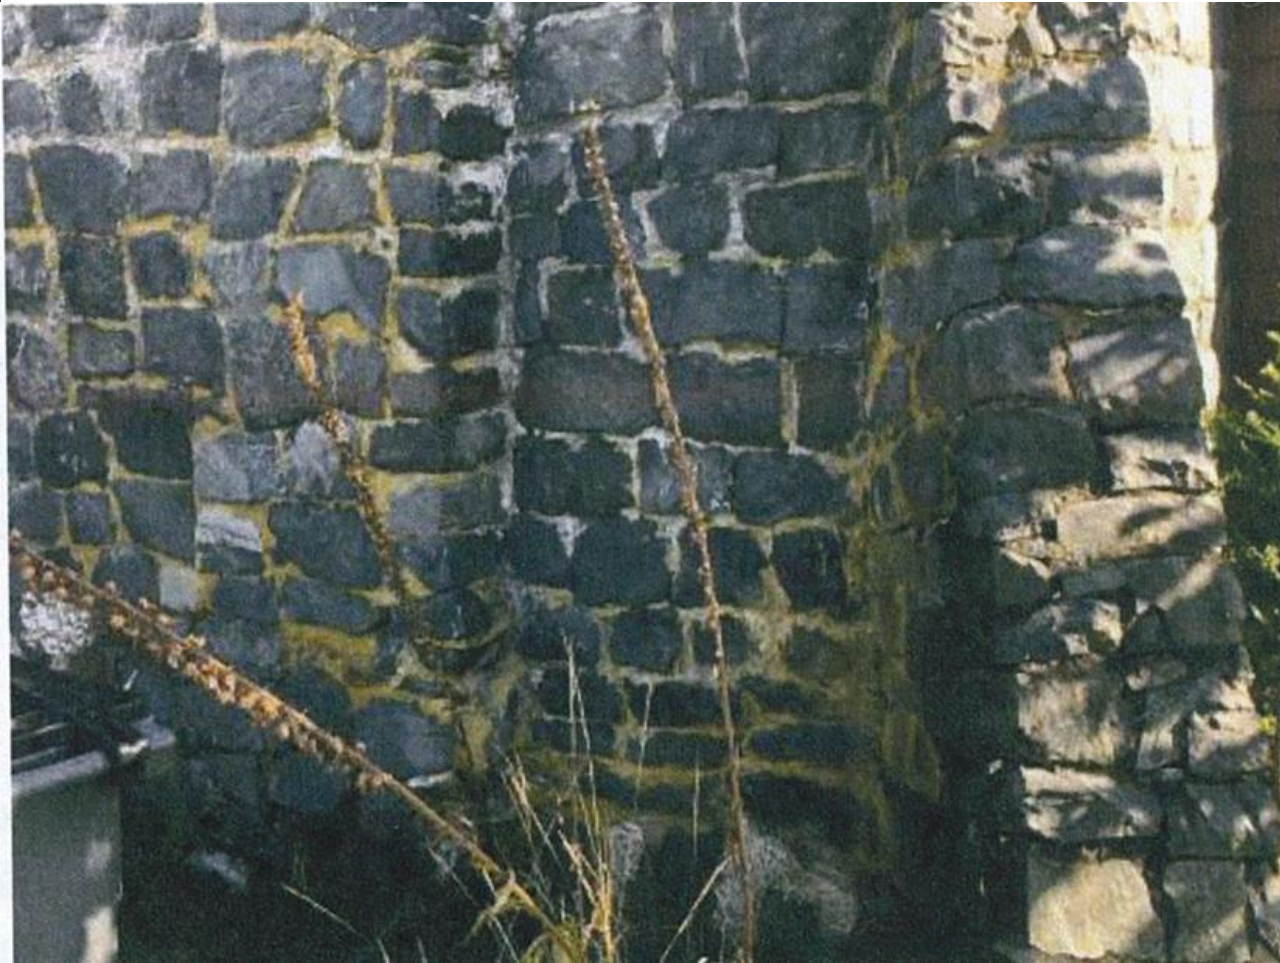
Algae/moss growth and efflorescence on all masonry need to be cleaned off.

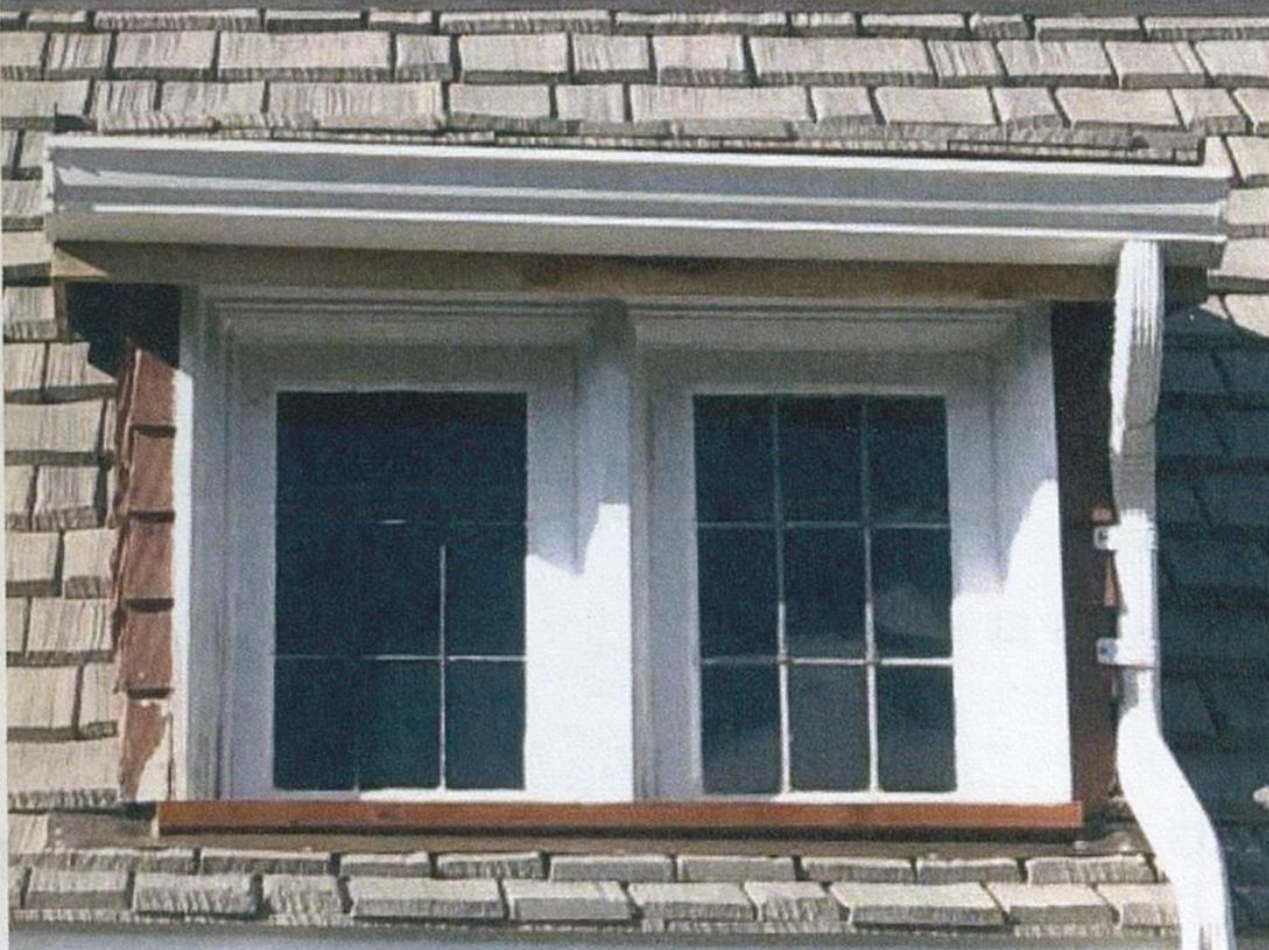
Overhang boards need to be replaced with in-kind beadboard as was originally installed.

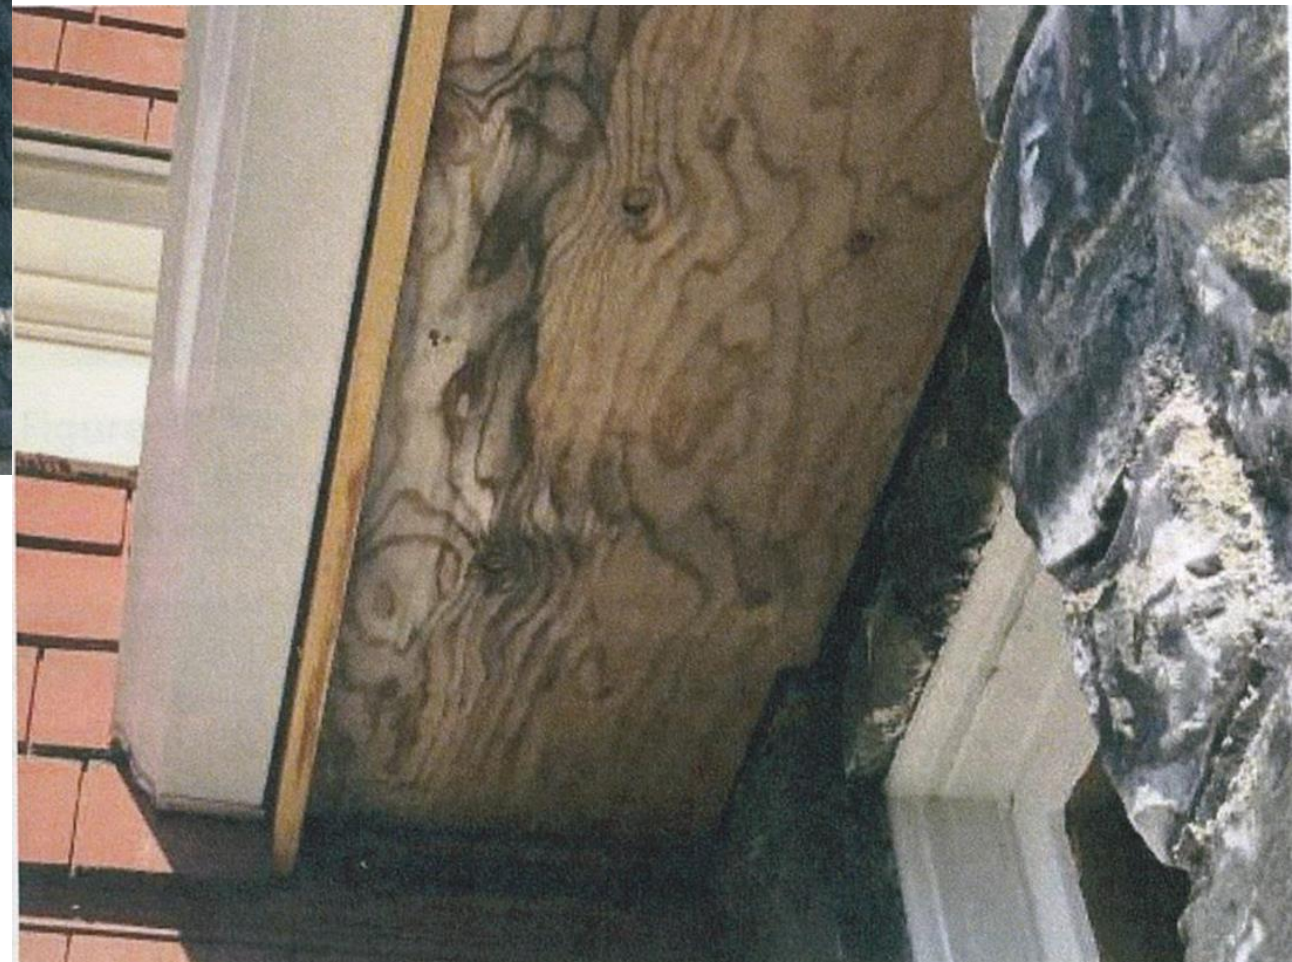
New fascia boards on second floor dormer needs to be painted.
