Grant Assessment Document Report

Projects requiring maintenance

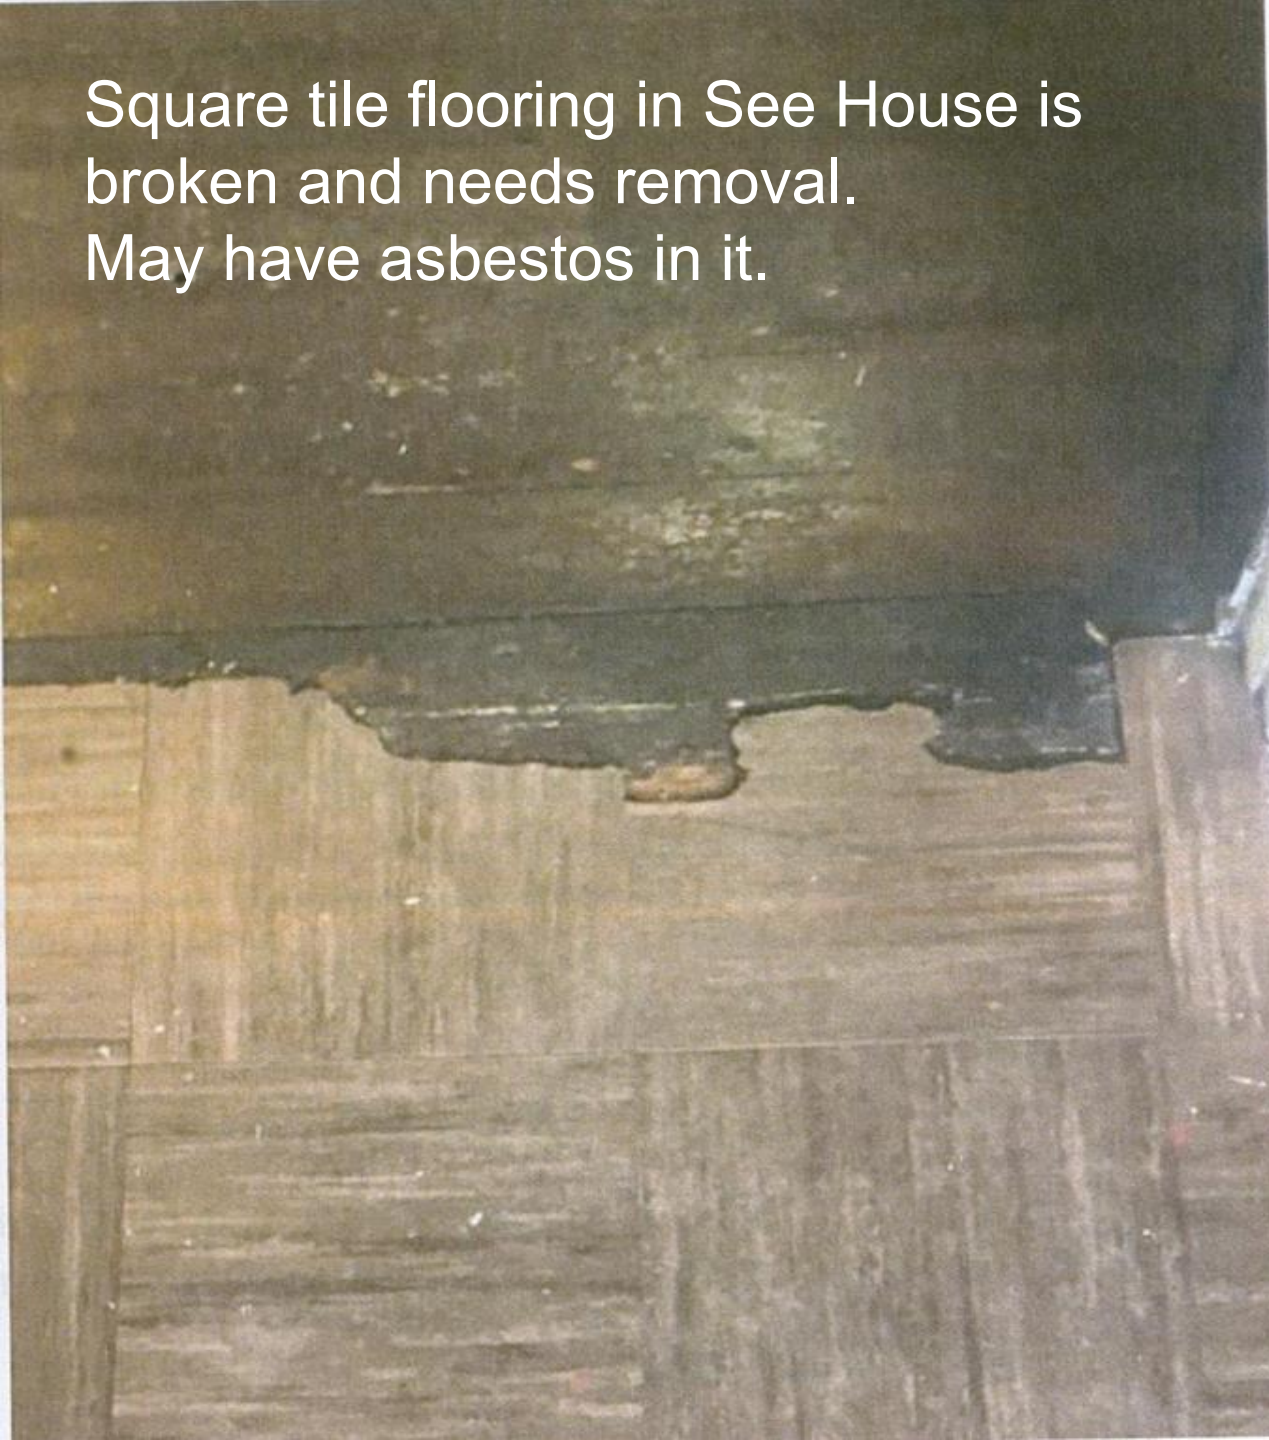
Square tile flooring in See House is broken and needs removal. May have asbestos in it.

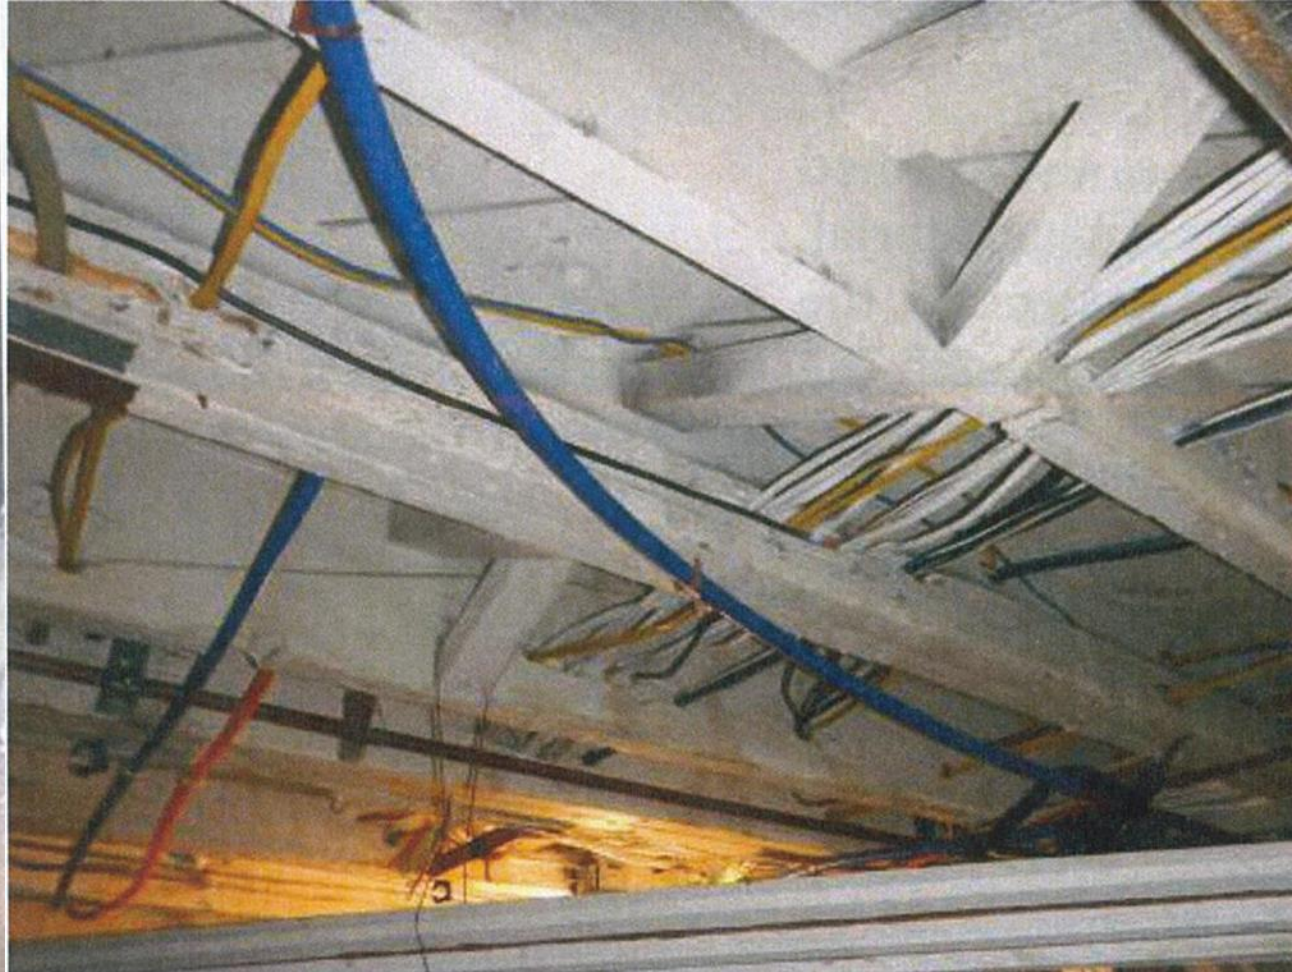
Wiring and other mechanical items run through floor joists in basement may have affected structural integrity of the joists. Recommend a structural engineer look and evaluate.

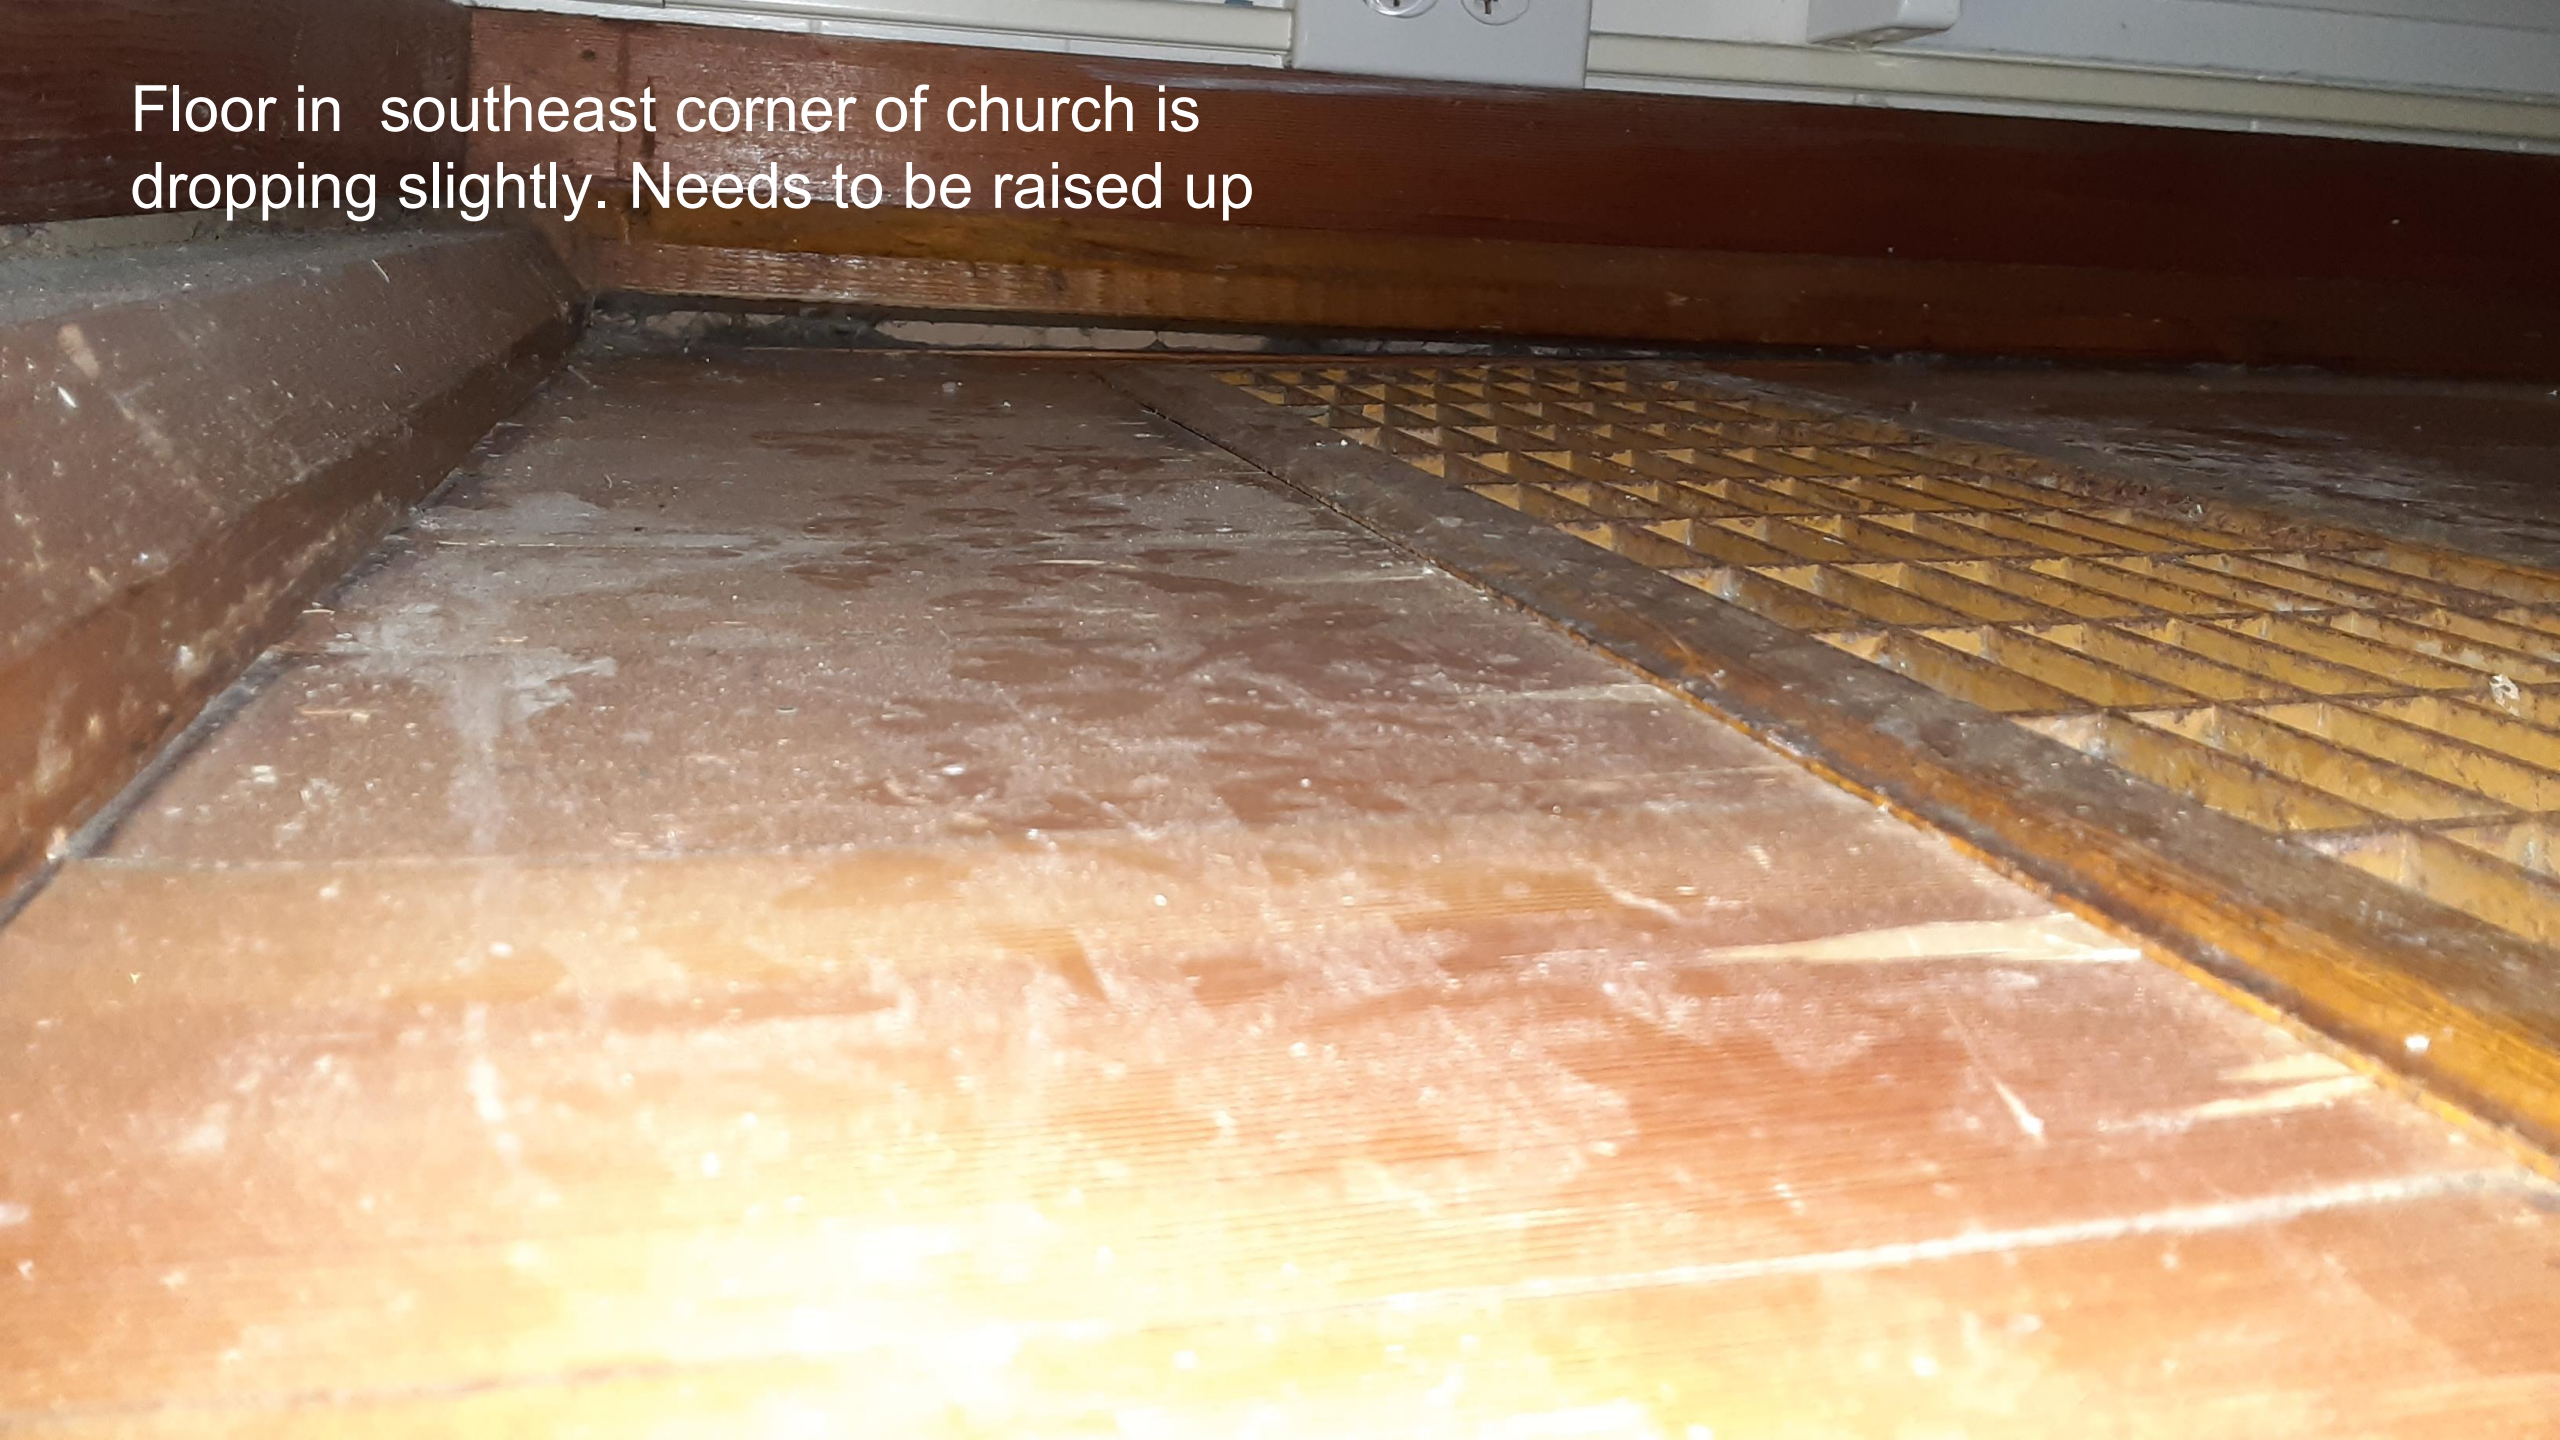
Floor in southeast corner of church is dropping slightly. Needs to be raised up

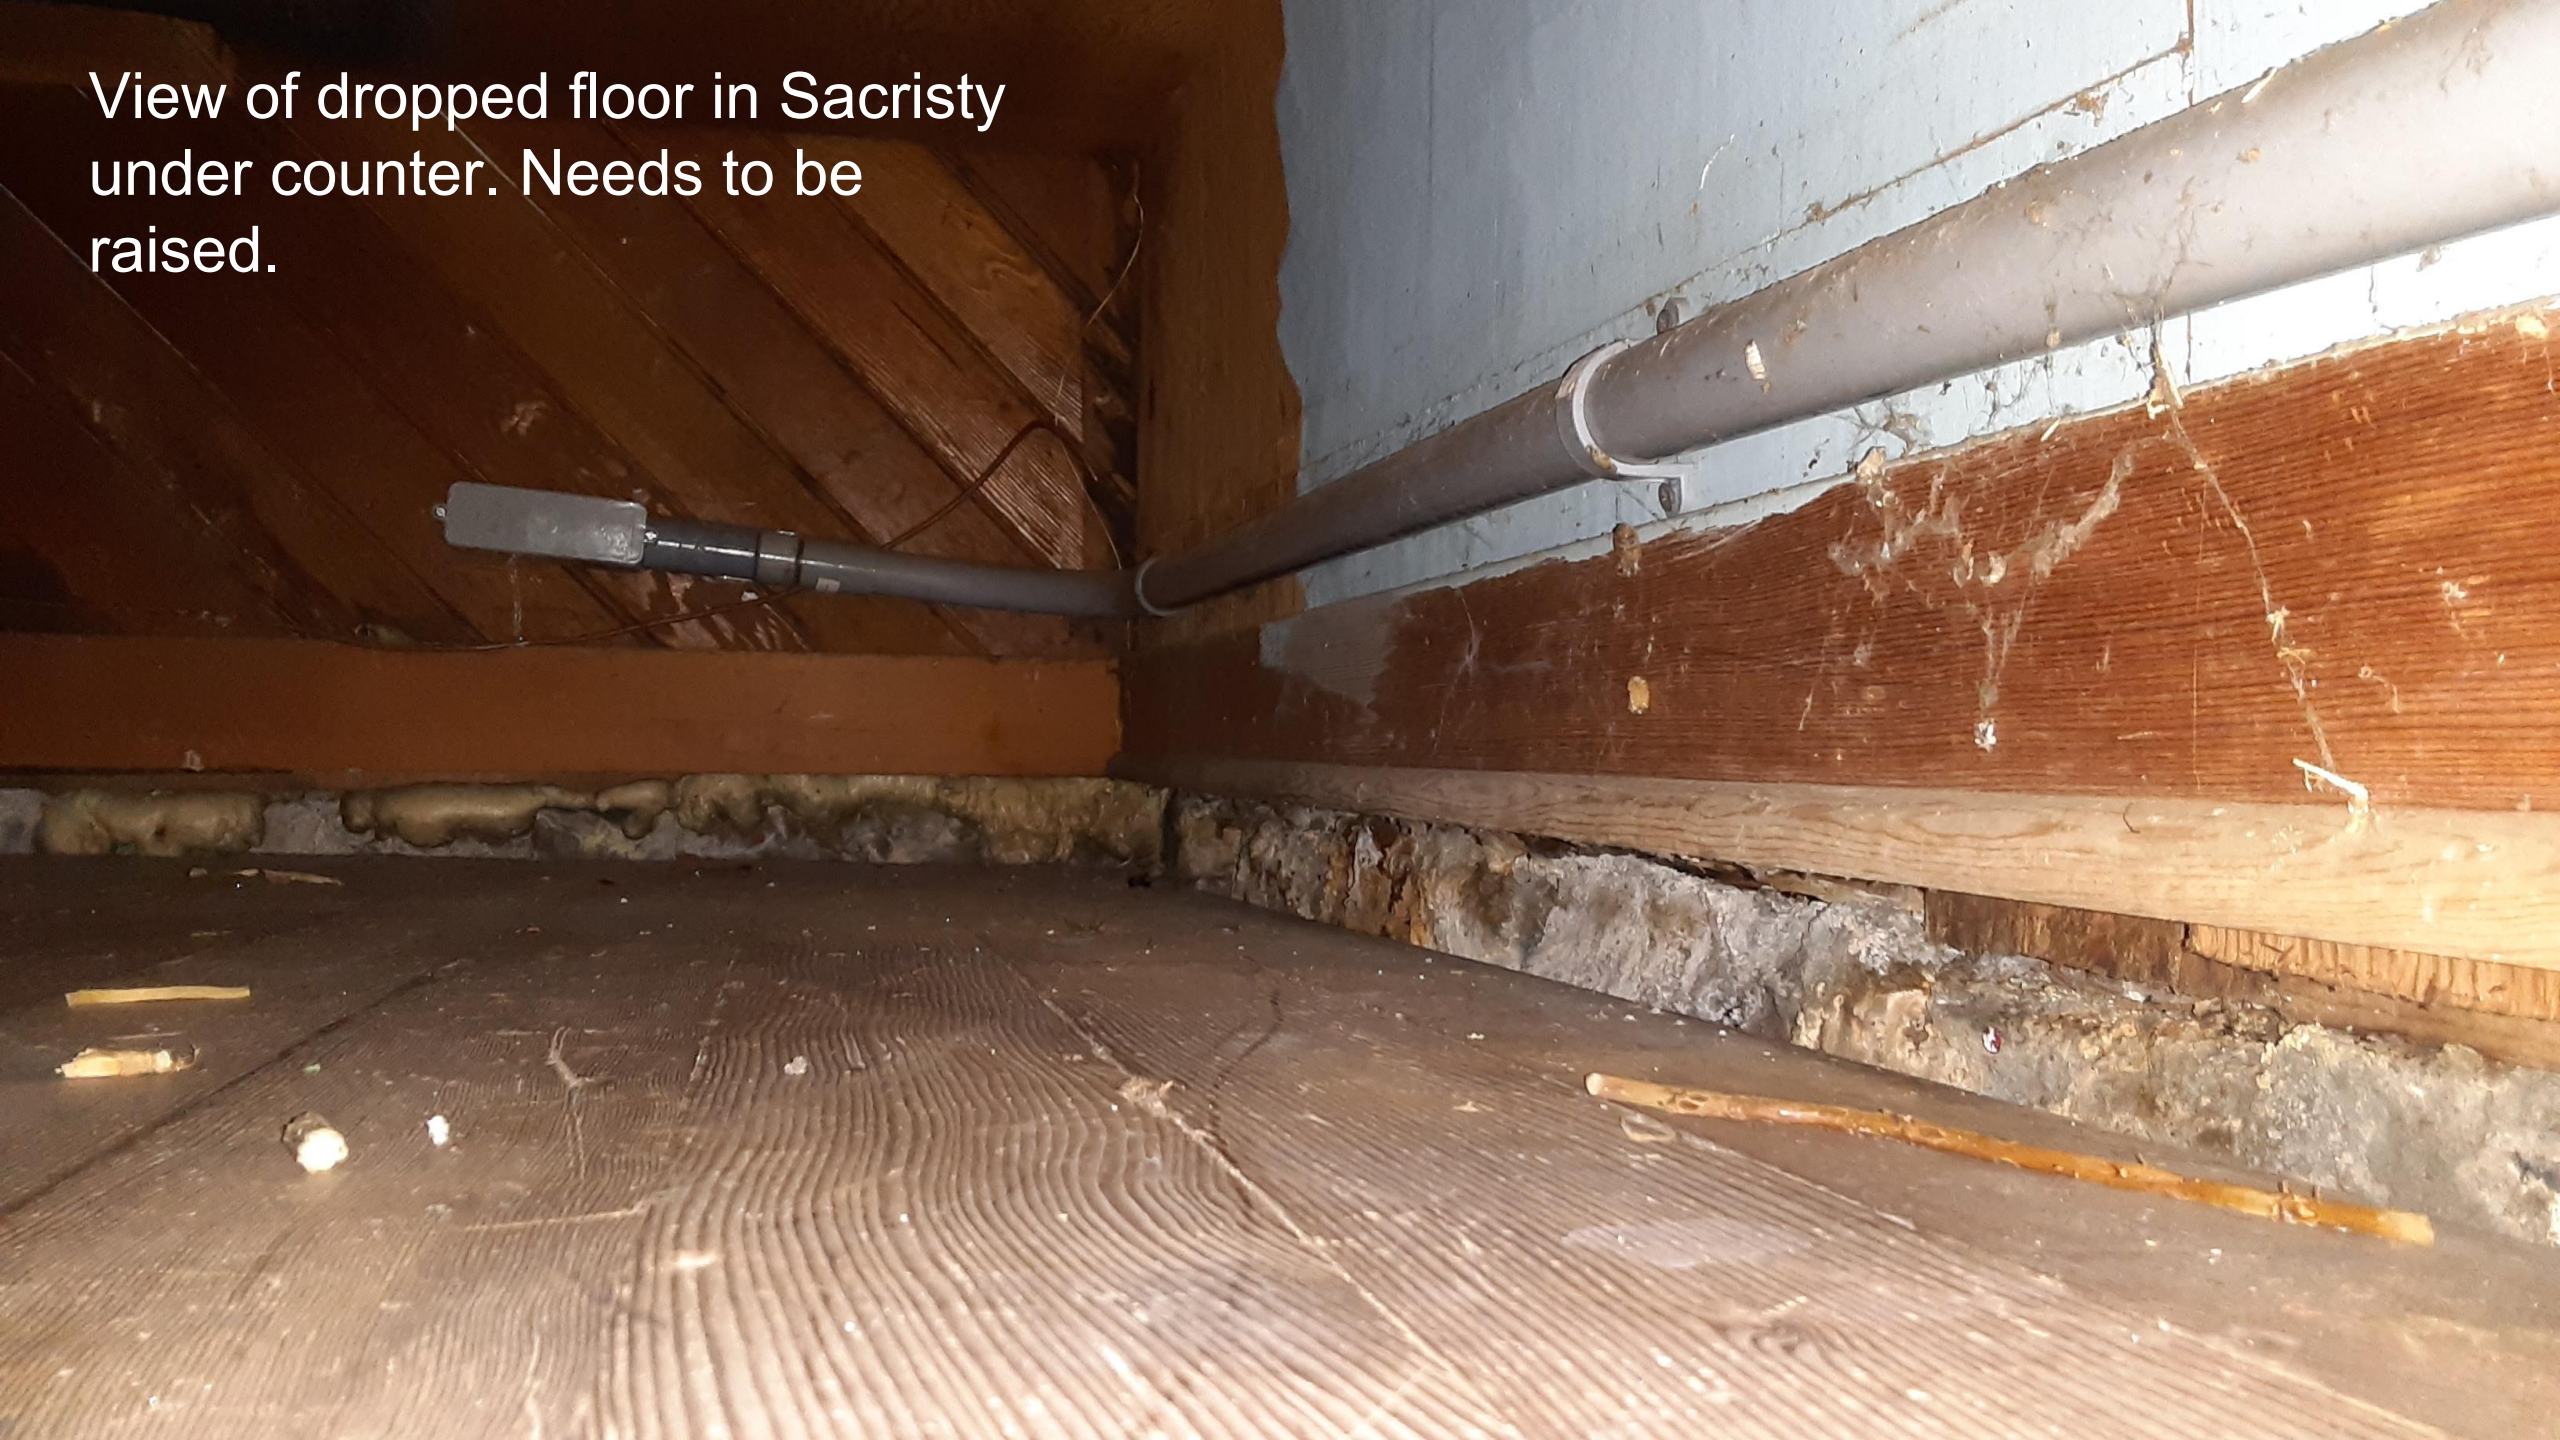
View of dropped floor in Sacristy
under counter. Needs to be
raised.

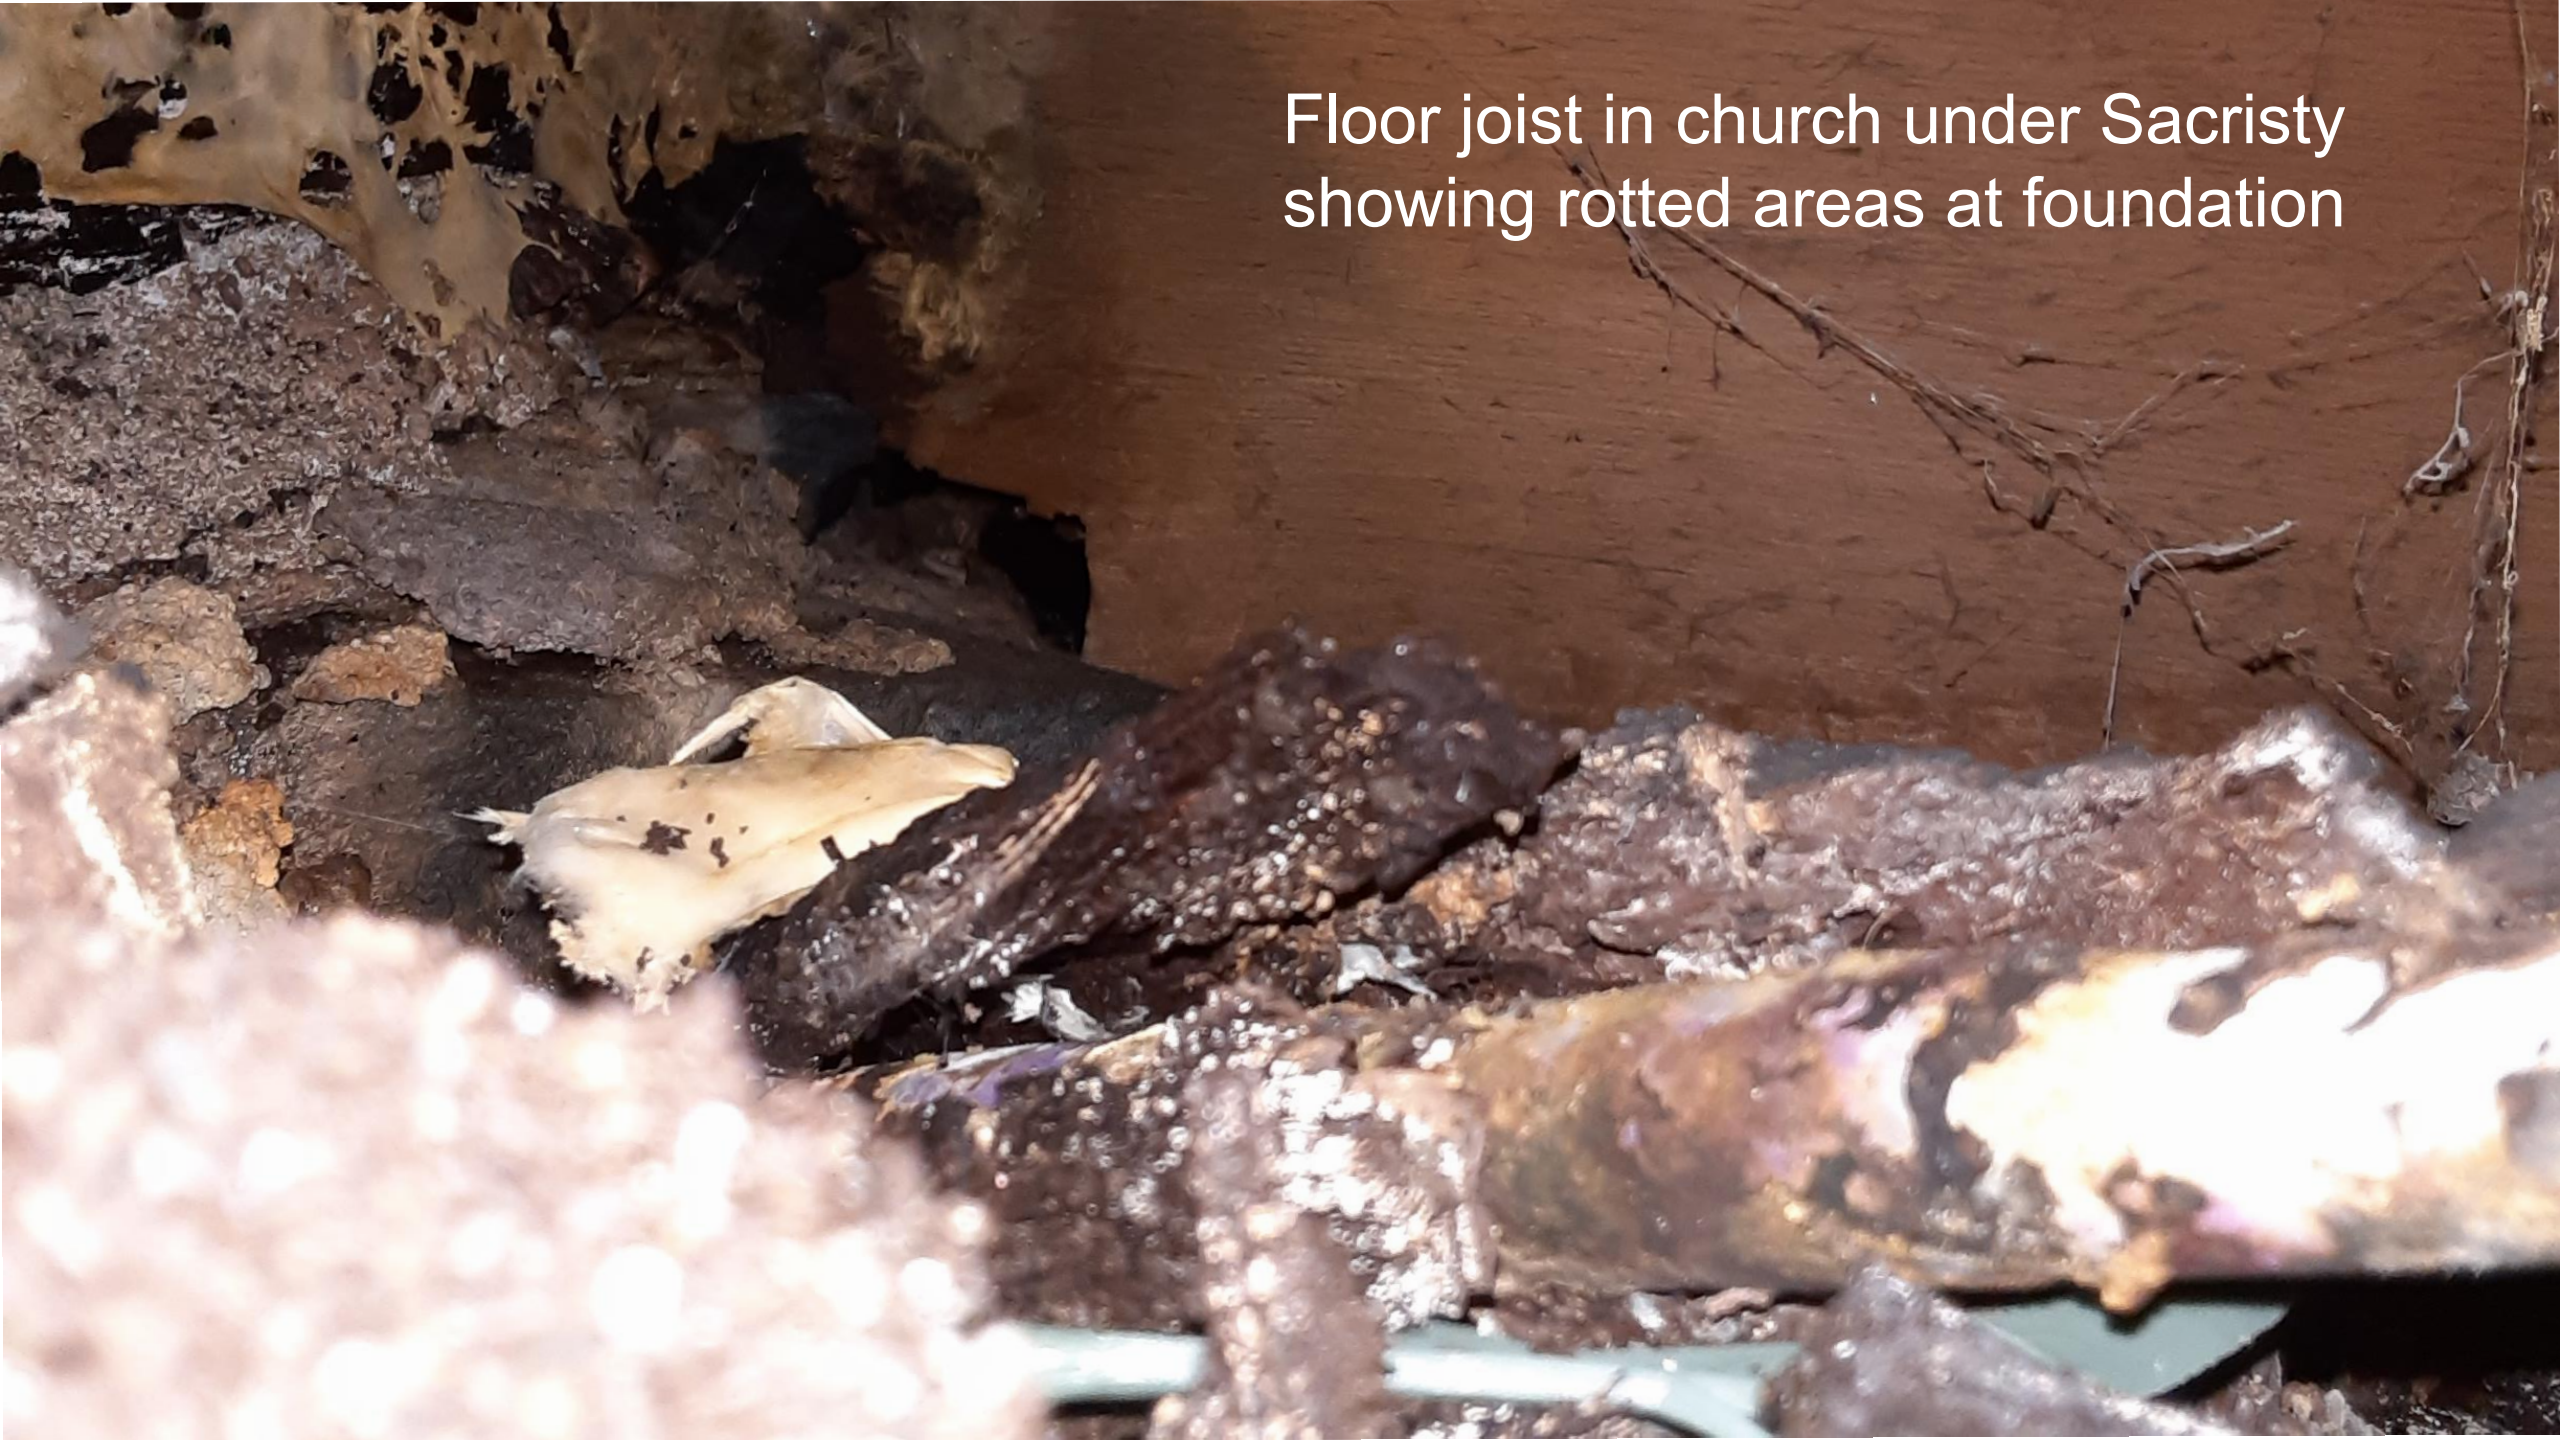
Floor joist in church under Sacristy
showing rotted areas at foundation
